# Study of degradation of spent fuel's structural material and core components under long-term wet storage

## 2023:11

**Author:** Gary Was, Matthew Eyre, Peter Rudling  
A.N.T. International, Tollerød, Sweden

**Date:** October 2023

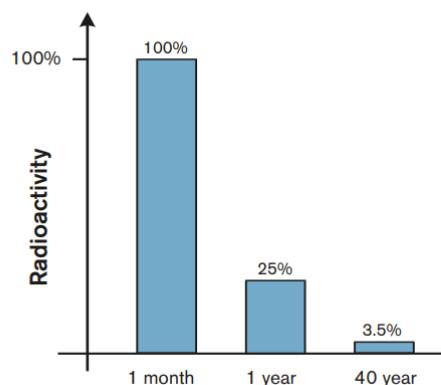
The radioactivity of the fuel increases sharply during the operation of a reactor. After about five years of use, the fuel is taken out of the reactor and is then at its peak radiotoxicity. After discharge, the quantity of radionuclides, and thereby the radiotoxicity of the fuel, declines as they decay. The spent nuclear fuel is first stored for some time in pools at the power plants, after which it is interim stored in Clab awaiting encapsulation and final disposal. The radioactivity decreases sharply during the Clab storage time, Figure 3.

**Figure 3:** Typical decrease of radioactivity in a tonne of spent nuclear fuel, modified Figure 3 according to [Svensk Kärnbränslehantering AB, 2011].

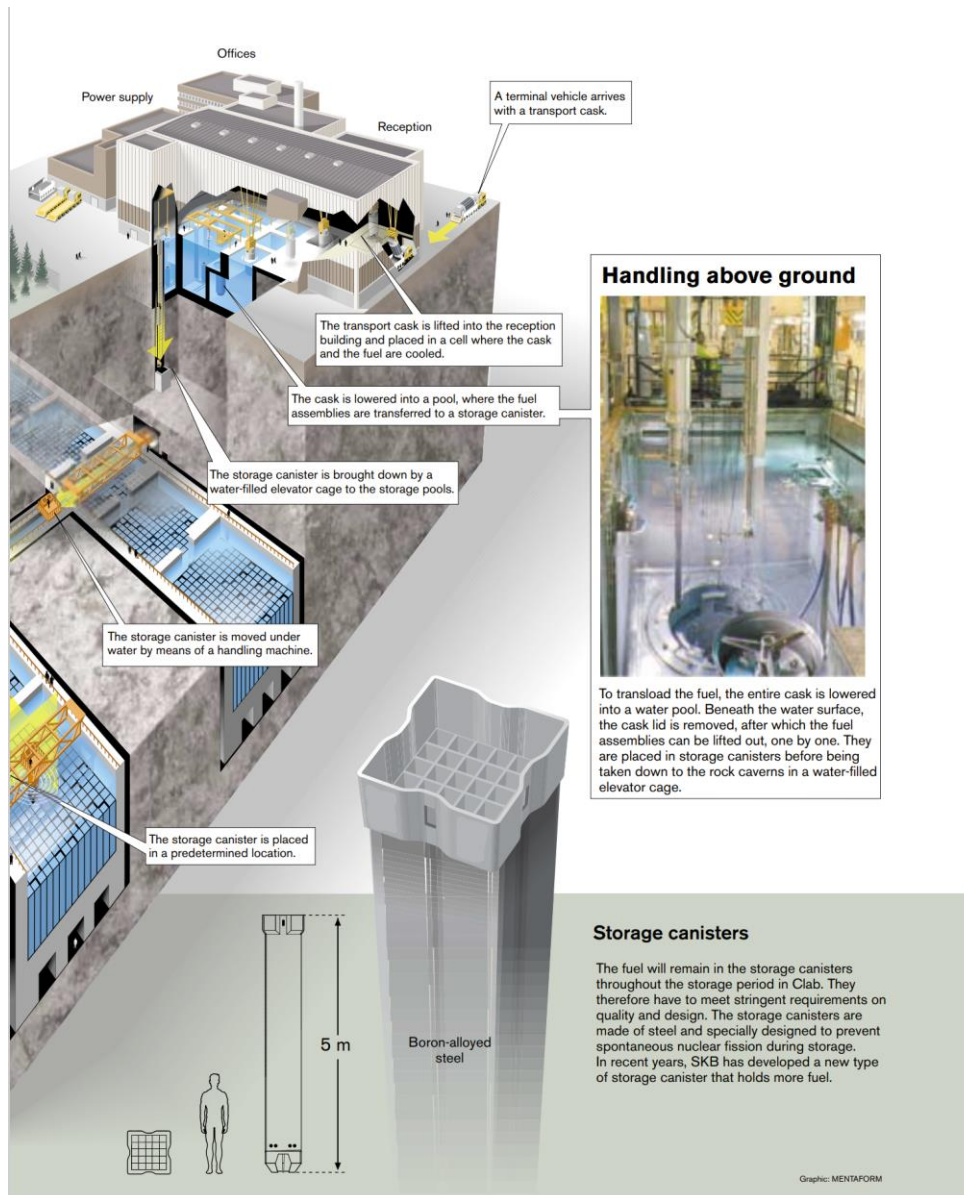
During interim storage at Clab, the spent fuel is kept in deep storage pools about 30 metres below ground in the rock, Figure 4 and Figure 5. Covering the fuel with eight metres of water shields against radiation and cools down the hot fuel. In 2022 SKB received the permit to expand Clab capacity to 11.000 tonnes [World Nuclear News, 2022].

Figure 4: Schematics of Clab<sup>2</sup>

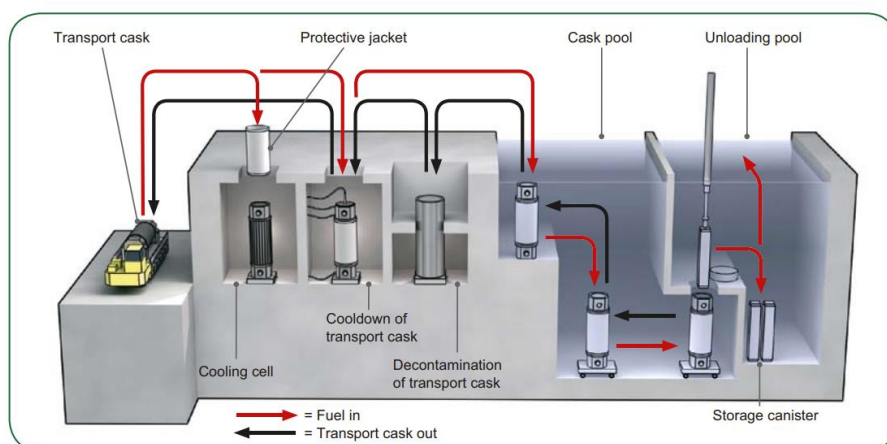
When the transport arrives at Clab (later Clink), the transport cask is inspected and transported to a cell for cooling. When the temperature has stabilised, the transport cask is transported to the cask pool and connected to the unloading pool. The fuel assemblies are unloaded and placed in the storage canisters in which they are kept during the interim storage. **If the assemblies are damaged, or suspected to be leaking, the storage canister is transported to a service pool and the assemblies are searched for damage. If necessary, damaged assemblies are put in protective boxes and placed in special storage canisters.**

**Figure 6:** Handling of transport casks in Clab's reception building [Svensk Kärnbränslehantering AB, 2011].

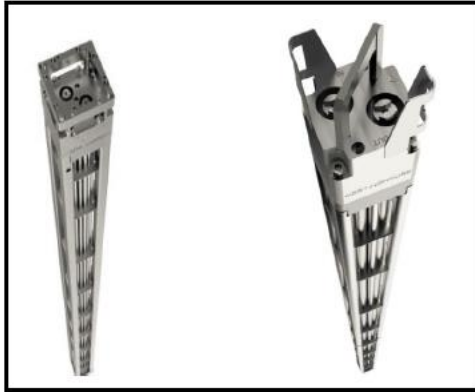
However, since several years back, all failed fuel, Figure 7, identified at the nuclear power site is loaded into a protection box, see Figure 8.

**Figure 8:** Westinghouse Quiver (Left: PWR version - Right: BWR version)

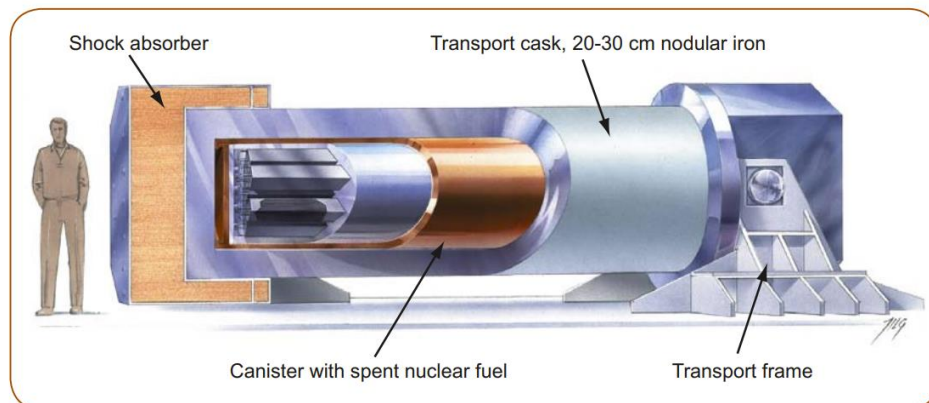
**Figure 11:** Canister transport cask and transport frame [Svensk Kärnbränslehantering AB, 2011].

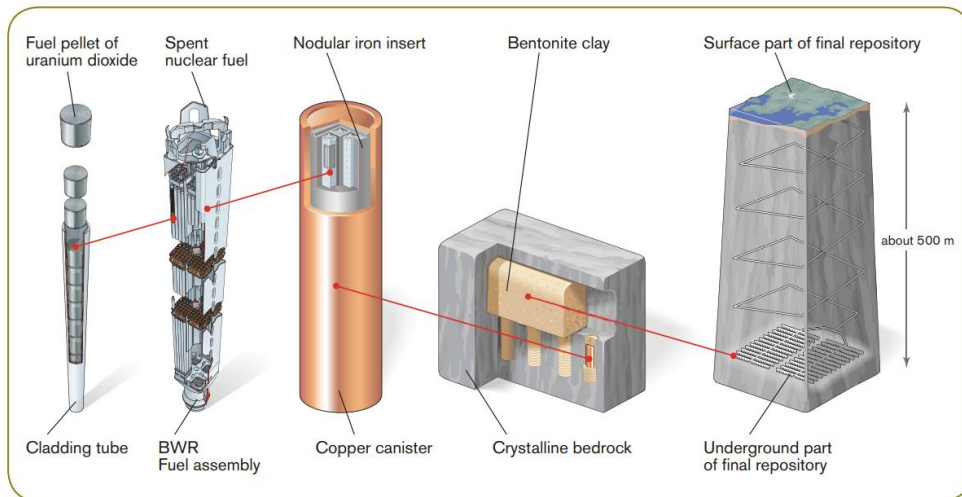
Figure 12 shows how the spent nuclear fuel is encapsulated in copper canisters which are then emplaced, surrounded by a buffer of bentonite clay, in deposition holes in a tunnel system at a depth of about 500 metres in the bedrock.

Figure 12: The KBS-3 method [Svensk Kärnbränslehantering AB, 2011].

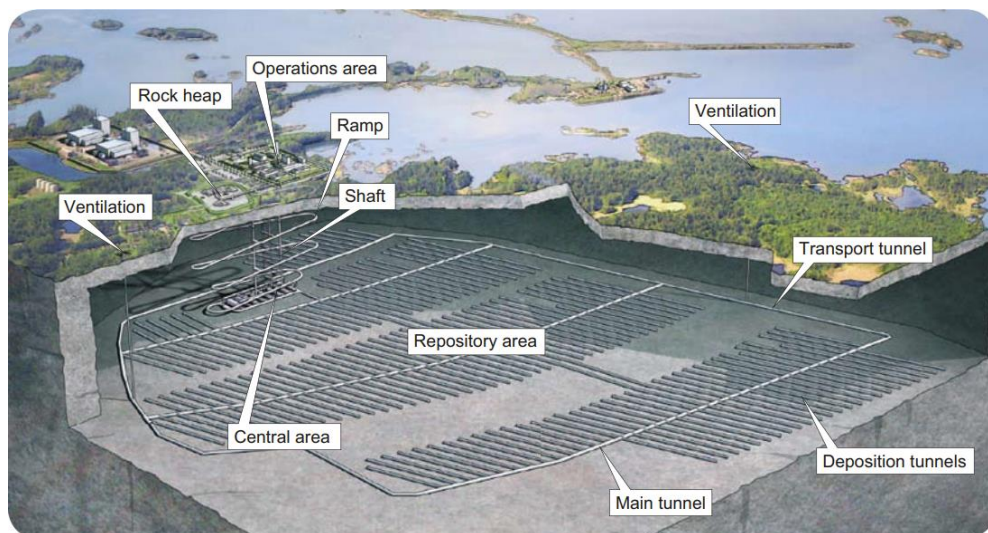
The final repository for spent nuclear fuel consists of a surface (above-ground) part and an underground part, see Figure 13.

Figure 13: The final repository with surface and underground parts [Svensk Kärnbränslehantering AB, 2011].

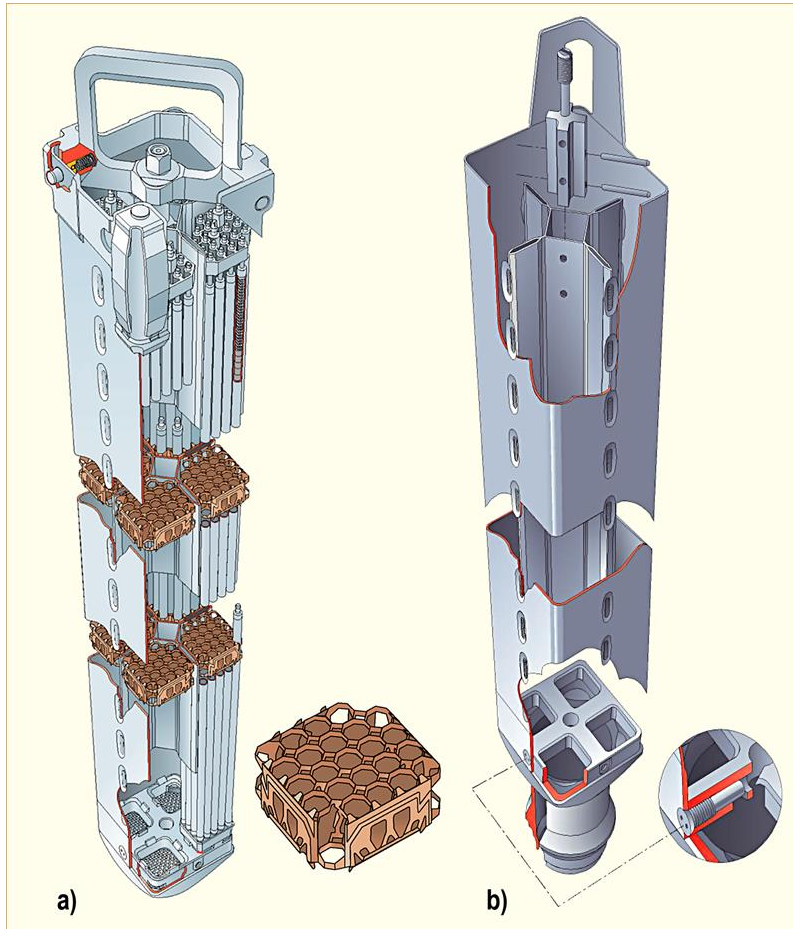
**Figure 15:** Fuel rod SVEA-96 Optima 2 BWR Fuel Assembly

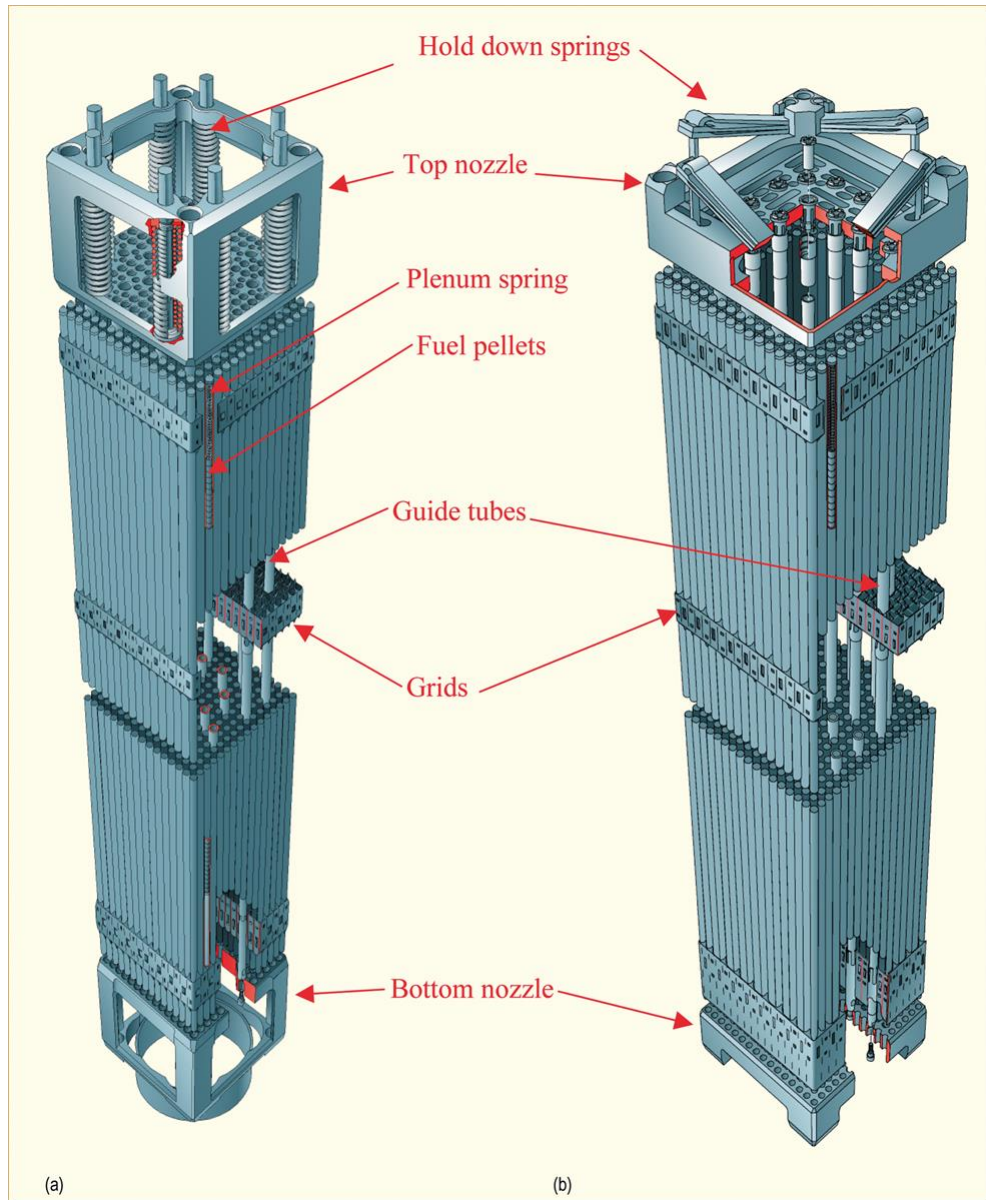
**Figure 16:** AREVA 17x17 PWR Fuel Assembly  
 a) German PWRs (16x16, 18x18) and  
 b) 17x17 design, provided by the courtesy of Westinghouse

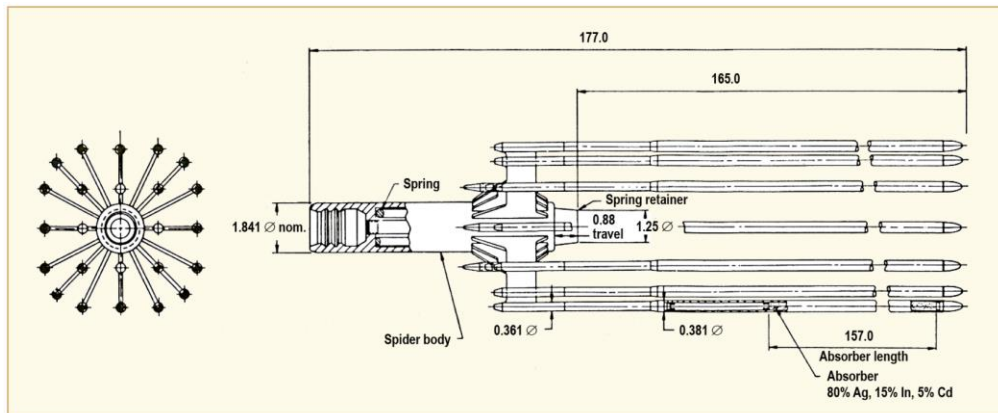
some hybrid rods substitute AIC for boron carbide ( $B_4C$ ) at the high exposure tips to provide a material with a lower swelling rate than  $B_4C$ .

**Figure 17:** Control Assembly (CA) for Westinghouse 17x17 fuel NSSS.

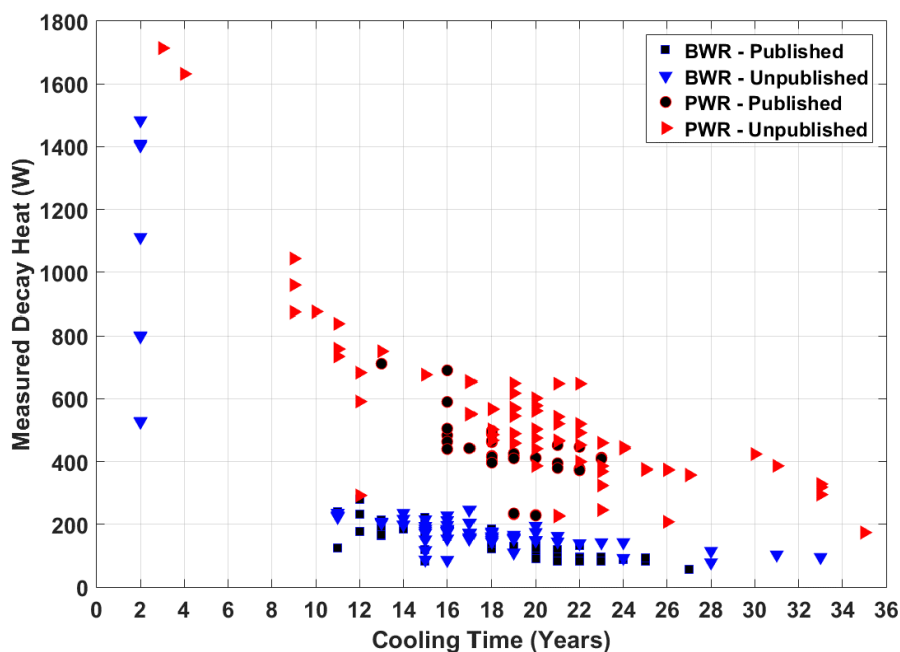
Figure 18: Measured decay heat as a function of cooling time [Svensk Kärnbränslehantering AB, 2006] and [PATRAM 22, 2023].

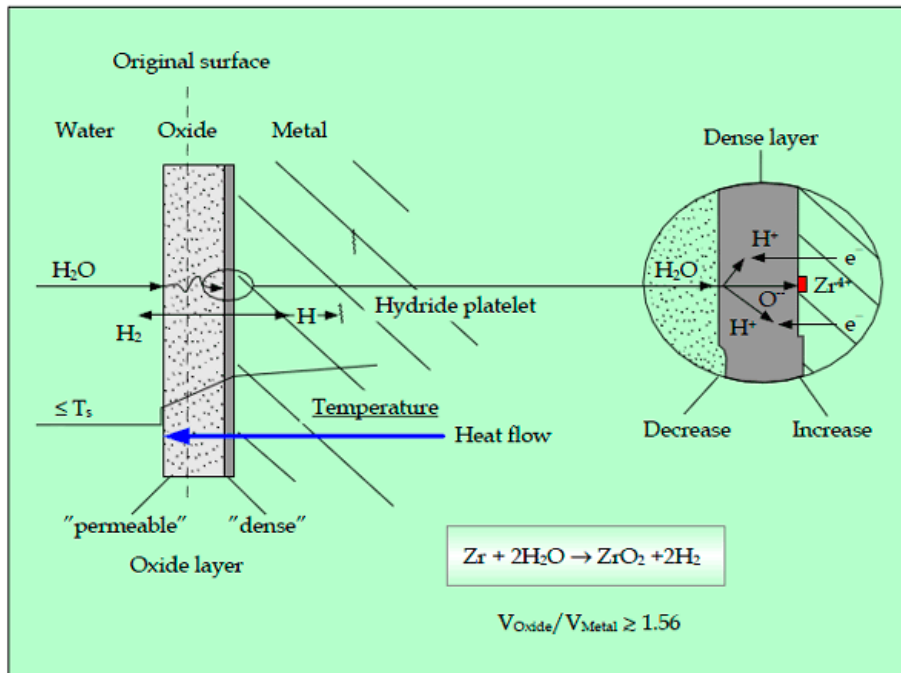
The H that is absorbed by the metal does so as an integral part of the reaction of Zr with the water molecule rather than by the reaction with any dissolved H in the water.

**Figure 19:** Schematics showing the Zr alloy corrosion and hydrogen pickup process of the fuel cladding, [Cox and Johnston, 1962] and [IAEA TECDOC-996, 1998].

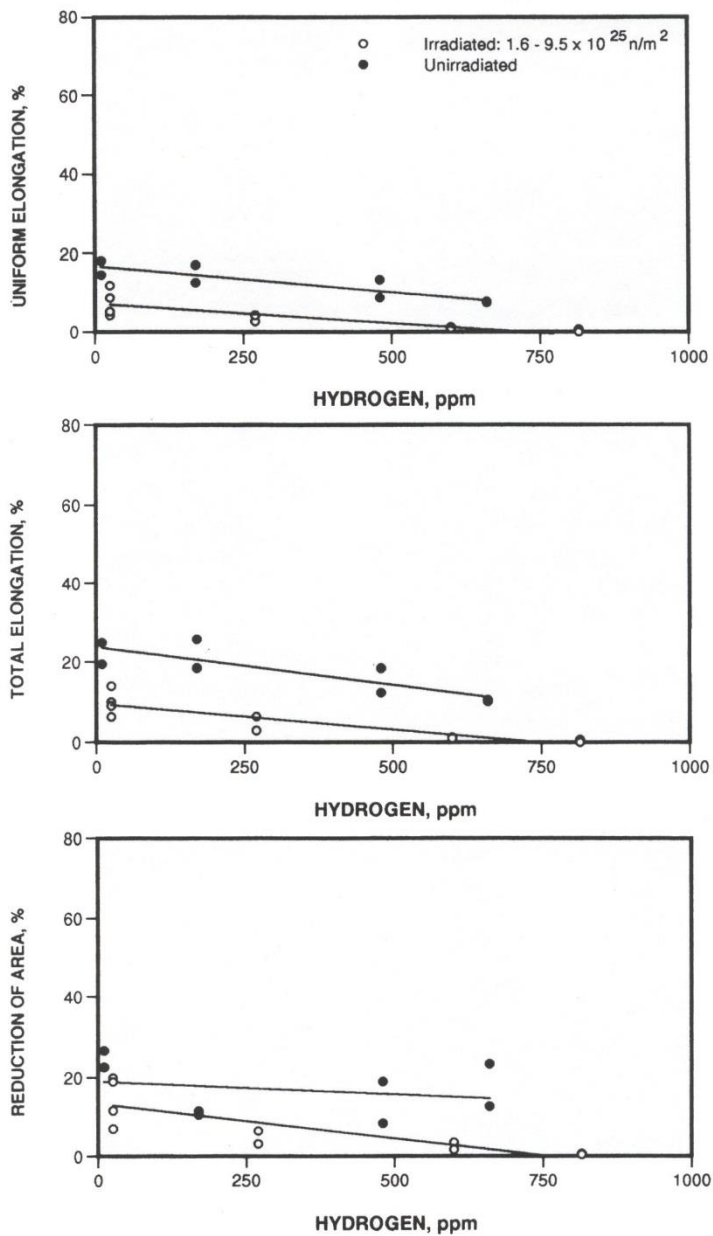
Typical, discharged fuel average hydrogen concentrations in fuel cladding have been measured to be in the range of 50 to 600 ppm. In very high burn-up fuel, hydrogen concentrations may exceed 1000 ppm. Once the hydrogen solubility limit in zirconium is reached, hydrides form which cause local embrittlement. This is especially the case in fuel materials subject to dual side corrosion such as BWR water rods and PWR control rod guide tubes. The solubility of hydrogen in Zirconium alloys at pool storage temperatures is less than 1 ppm. Therefore, essentially all hydrogen in LWR fuel cladding in pool storage will exist as hydrides. Irradiated Zirconium alloys containing significant amounts hydrides have very low ductility, Figure 20 and Figure 21.

**Figure 20:** Uniform and total elongation and reduction of area as a function of hydrogen for unirradiated and irradiated Zircaloy-2 LDA specimens tested at 295 K [Wisner and Adamson, 1998].

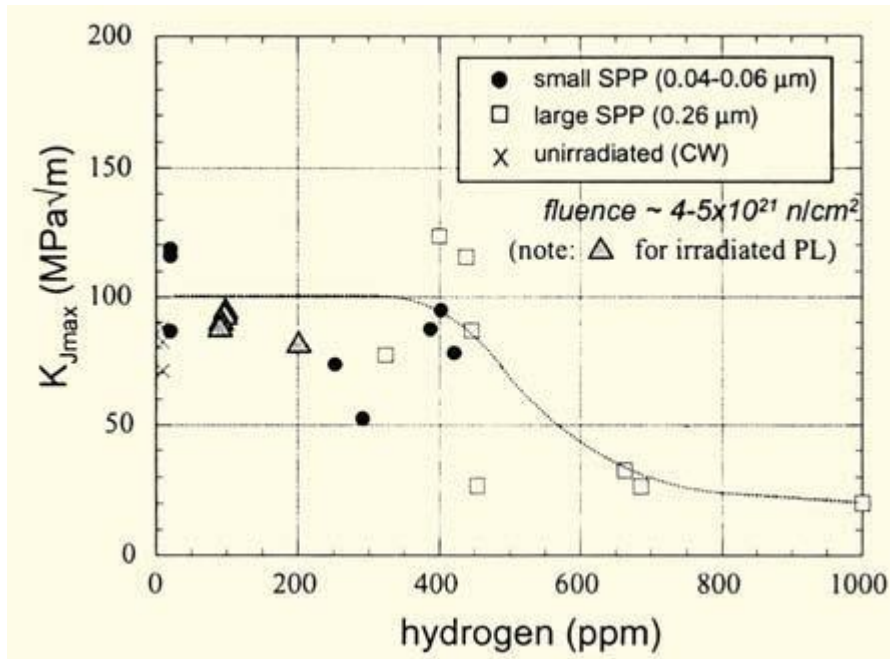
**Figure 21:** Fracture toughness results from irradiated Zircaloy as a function of hydrogen, using VEC and PLT techniques [Edsinger et al., 2000]

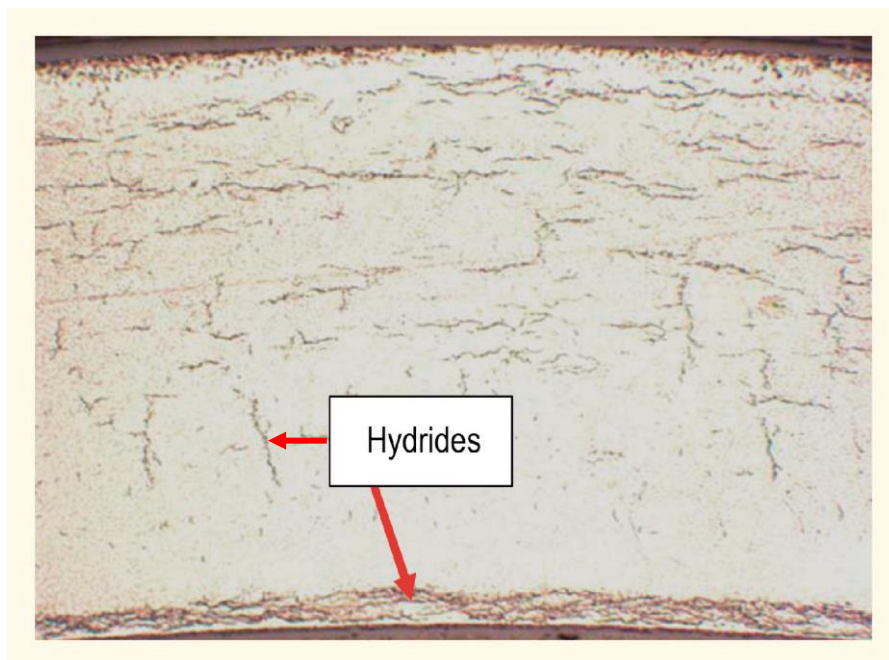
Figure 22 shows an example of hydrides in nuclear fuel cladding. The radially oriented hydrides can provide a path of low ductility for the propagation of cracks through the wall of zirconium alloy tubing.

**Figure 22:** Hydrides in a BWR fuel cladding cross section at mid height position from KKL with an H-content of 220 ppm after a bundle burnup of 60 MWd/kgU [Strasser et al., 2008]

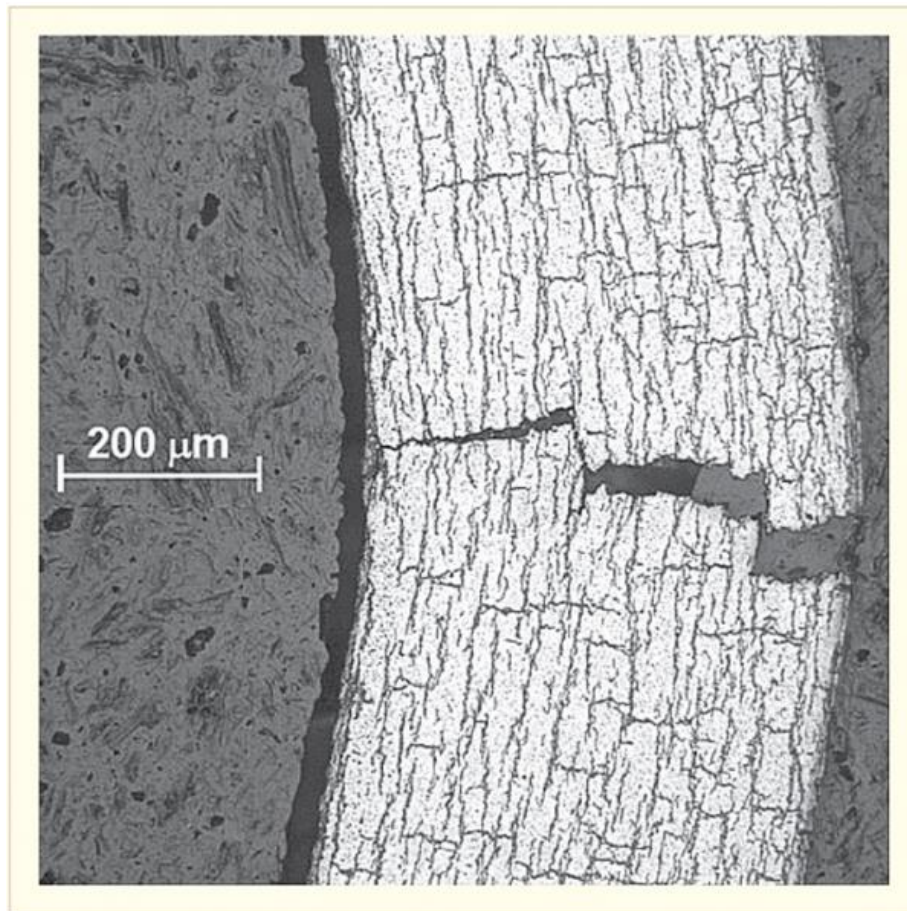
**Figure 23:** Distribution of hydride platelets on a transverse-radial plane in ZIRLO (Zr1Sn1Nb0.1Fe) fuel cladding containing 630 ppm hydrogen cooled from 400°C with hoop stress of 190 MPa [Billone et al., 2013].

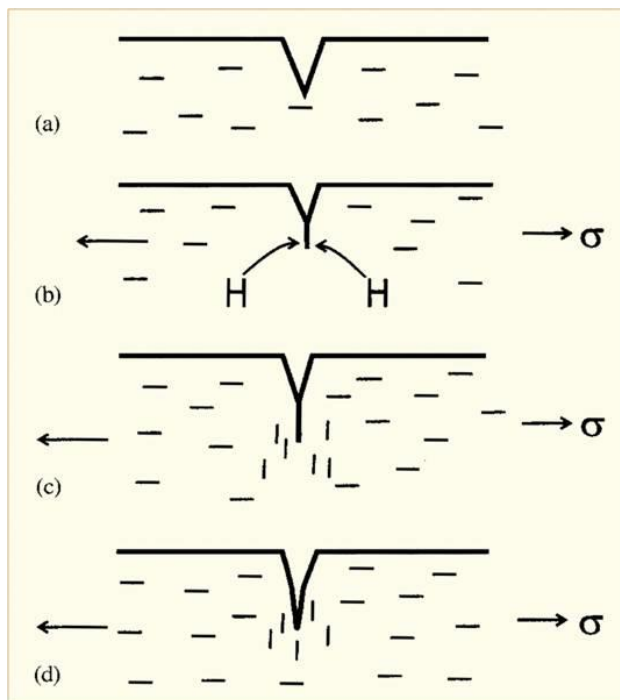
may have hydrides parallel with the surface. In fuel cladding, hydrides tend to have a circumferential orientation. If a tensile stress ( $\sigma$ ) is applied, (b), hydrogen diffuses up the stress gradient close to the flaw tip [Dutton and Puls, 1976] and [Dutton et al., 1977]. New hydrides will precipitate at the flaw if sufficient hydrogen accumulates above the solubility limit. In fuel cladding stressed in the hoop direction, the new hydrides will be radially oriented. With time, the flaw tip hydride grows larger and more hydride accumulates (c). If the critical conditions of hydride size, stress and strain are reached, the hydride at the flaw tip cracks and the crack extends by the length of the hydride (d). The process of hydride nucleation, growth and fracture may repeat and the crack extend potentially becoming a through-wall defect.

**Figure 24:** Schematic diagram of the traditional mechanism of DHC. A component or specimen of zirconium alloy contains circumferential hydrides and a surface flaw, (a). When a tensile stress is applied, hydrogen in solution diffuses up the stress gradient at the flaw tip and forms a hydride, which is reoriented in this example, (b). With time this hydride grows and more reoriented hydrides are formed around the flaw tip, (c). Once a critical condition is reached the hydride closest to the flaw tip cracks, (d). The process is then repeated [Coleman, 2003].

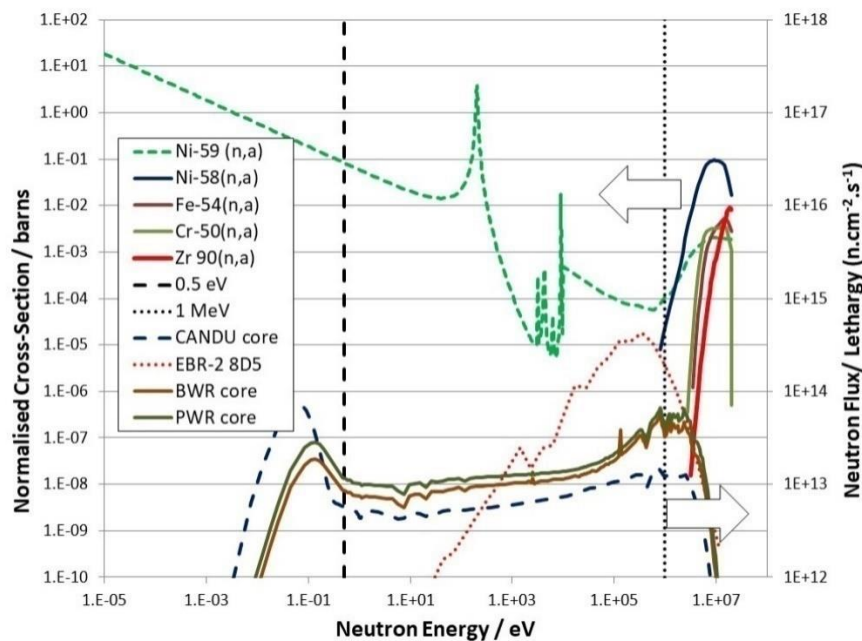
**Figure 25:** Normalised cross-section as a function of neutron energy for different reactor types [Griffith, 2023]

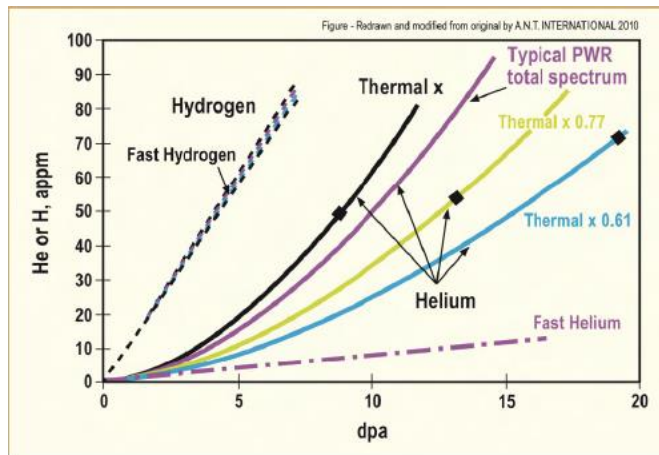
**Figure 26:** Helium and hydrogen production from transmutation reactions in stainless steel as a function of neutron fluence and energy [Garner F et al., 2002].

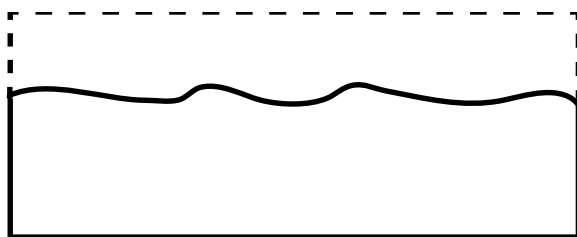
**Figure 27:** General or Uniform Oxidation (courtesy of G. Was) [Jones, 1996]

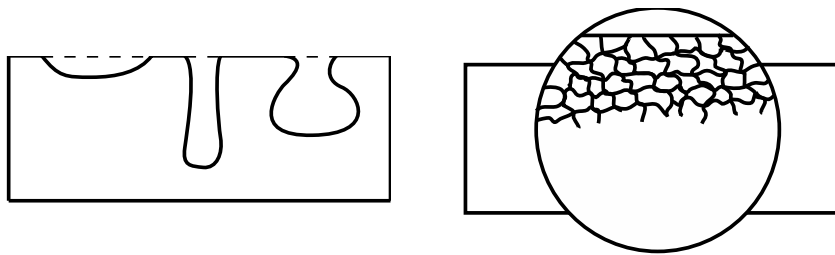
**Figure 28:** Pitting corrosion (left) and intergranular corrosion (right) (courtesy of G. Was) [Jones, 1996].

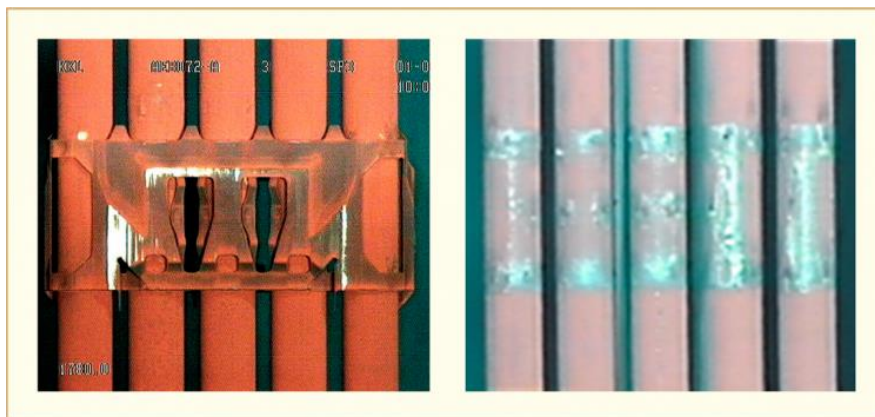
Inconel spacers cast a “shadow” on fuel rod cladding (Figure 29) that accelerate localized corrosion.

**Figure 29:** Appearance of Inconel spacer induced shadow corrosion on Zry-2 cladding. The photo to the right is the same assembly as shown to the left but after the spacer has been removed and the rods have been brushed to remove the loosely adherent CRUD [Châtelain et al., 2000] and [Ledergerber et al., 2006].

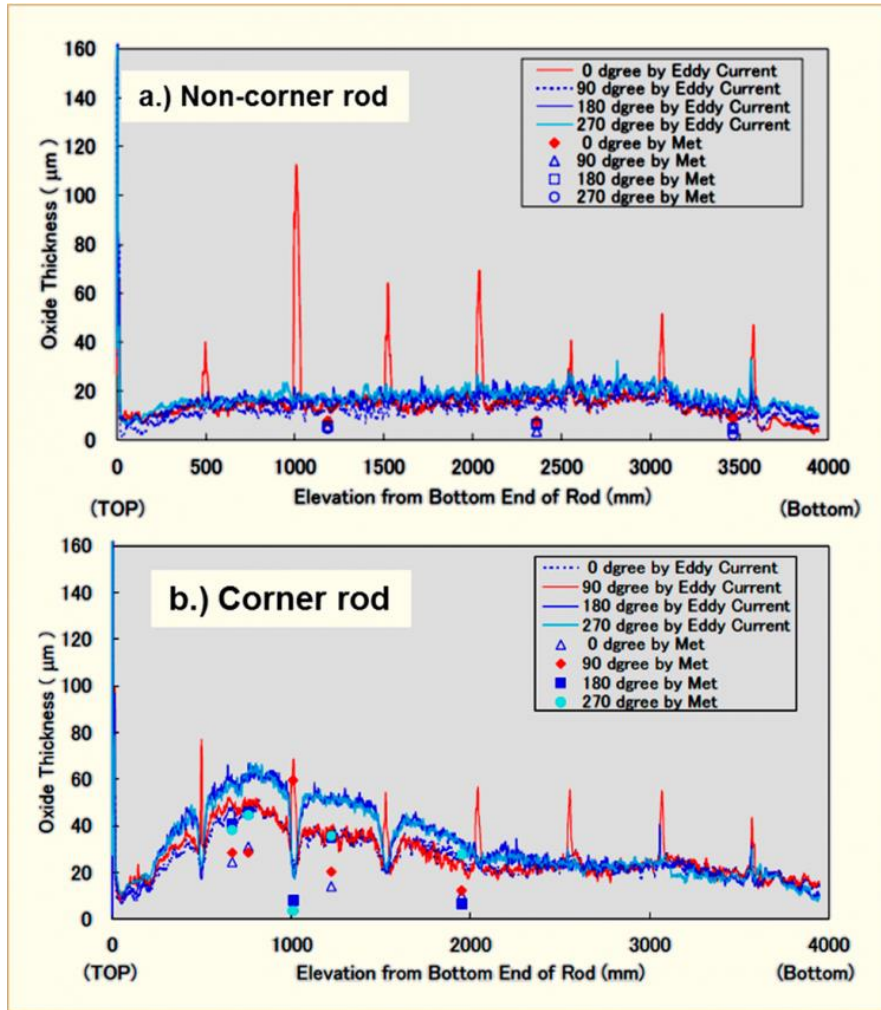
The oxide thickness at these positions is increased relative to the rest of the fuel rod cladding (Figure 30 and Figure 31). The red spikes in the oxide measurement occur that the spacer grid locations.

**Figure 30:** EC Oxide film profile line scans from different peripheral positions from 2 fuel rods of a 9x9 BWR fuel assembly with bi-metallic ferrule springs exposed in Fukushima to a burnup of 55 MWd/kgU [Miyashita T. et al., 2007]

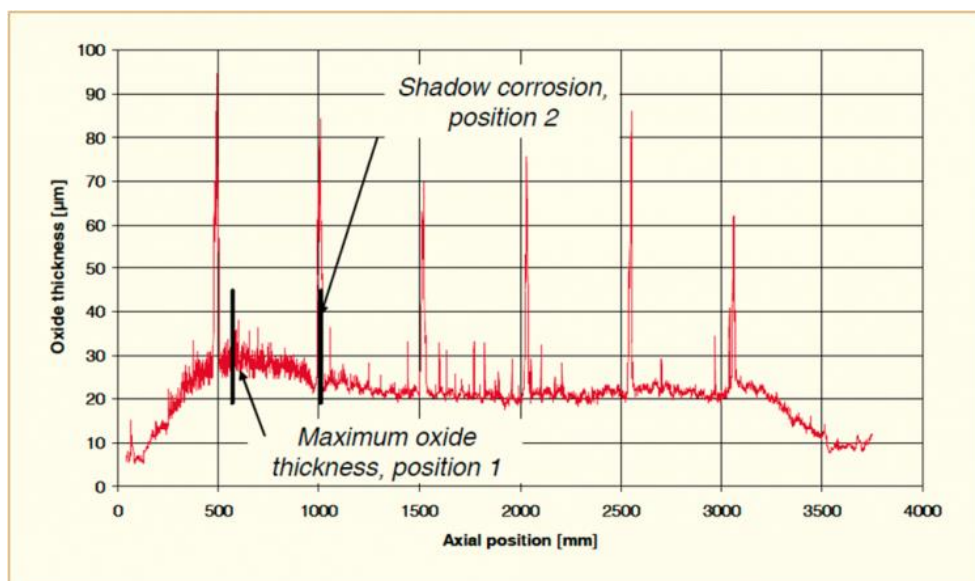
**Figure 31:** Oxide profile of ATRIUM 10P fuel rod with all-Inconel spacers [Hoffmann et al., 2005]

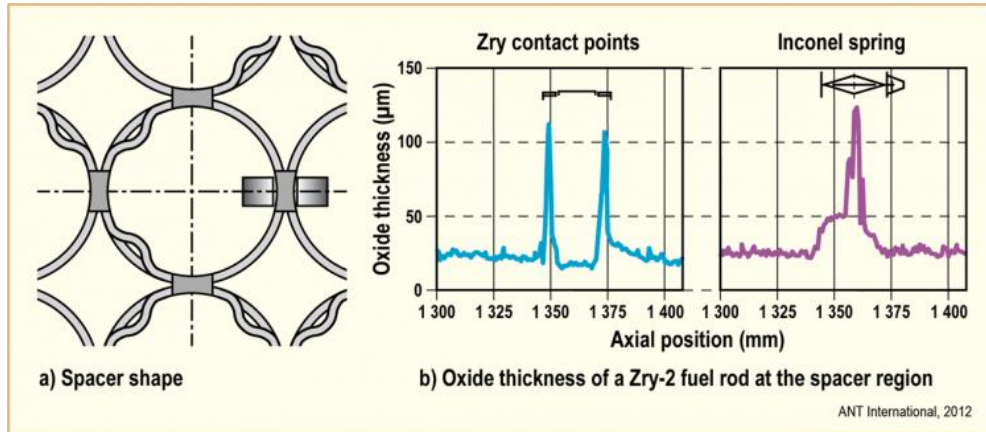
Another shadow corrosion example involves a bi-metallic ferrule spacer where the oxide thickness peaks opposite the Inconel springs (Figure 32) and opposite the Zry-4 contact points. In another series of measurements, oxide peaks were noted only at the Inconel spring contact point (Figure ) [Miyashita T. et al., 2007].

**Figure 32:** Oxide layer thickness profile of a BWR Zry-2 fuel rod opposite to Zry contact points and Inconel contact point after a burnup of 46 MWd/kgU [Garzarolli et al., 2001]

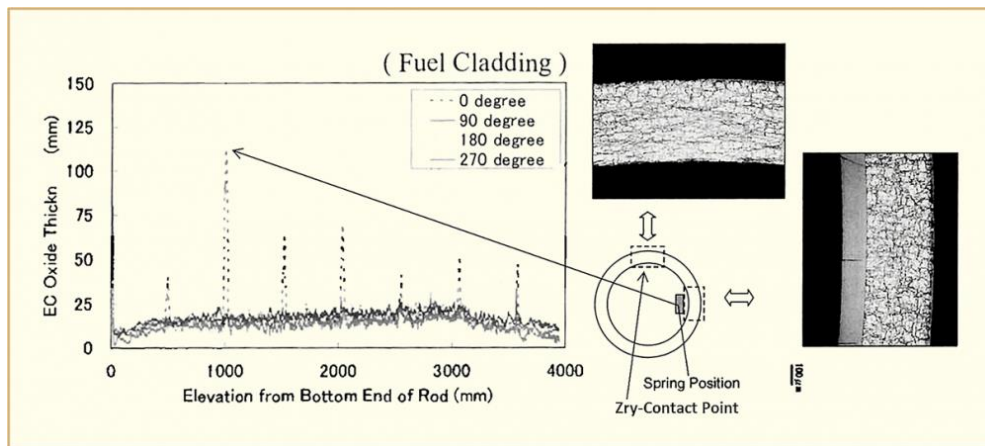
**Figure 33:** Oxide profile and metallography of the 2nd ferrule spacer after a burnup of 45 MWd/kgU [Miyashita T. et al., 2006]

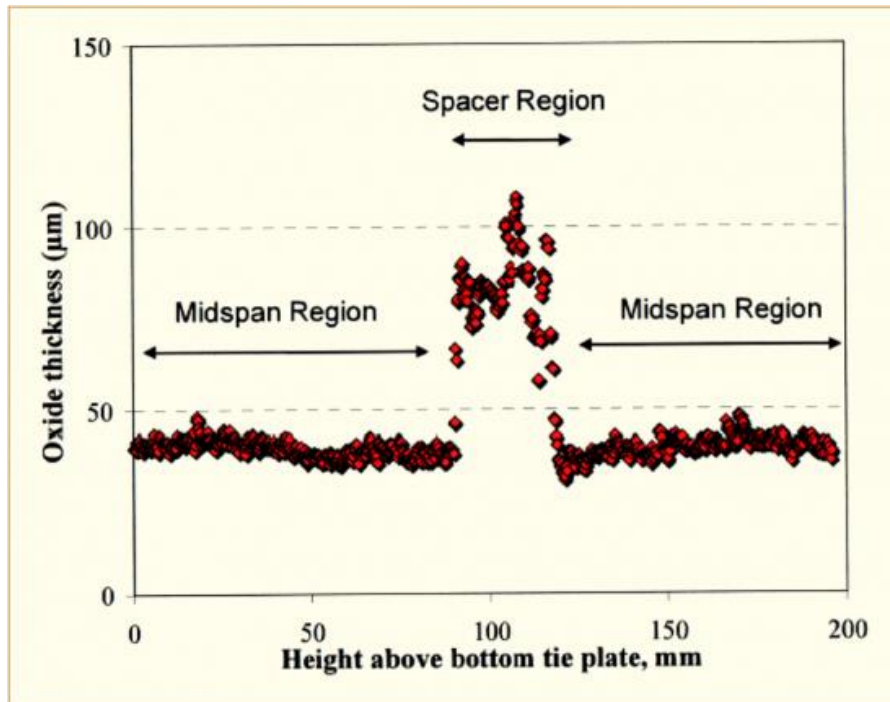
With Inconel spacers, the oxide thickness is increased in the entire area below the spacer strip (Figure 34). The fuel cladding maximum oxide thickness is observed at positions where Inconel is in contact or close to the zirconium alloy cladding, whereas at positions at the spacer corners, where the cladding-spacer distance is larger, the oxide is only slightly increased.

**Figure 34:** Oxide thickness profile on a fuel rod overall Inconel spacers [Kelen et al., 2000]

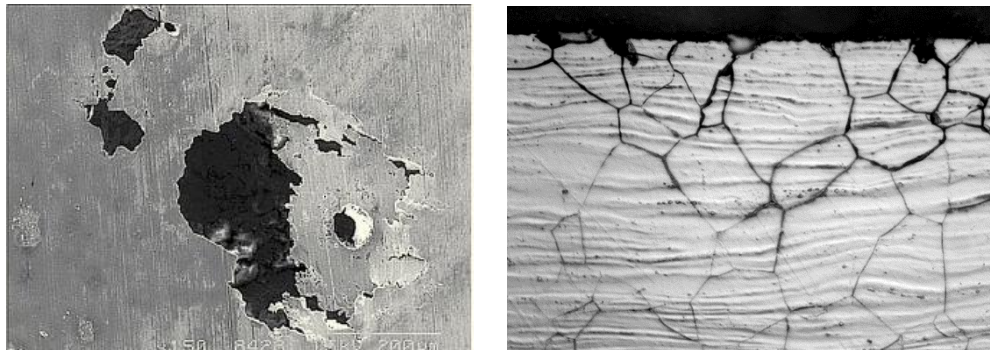
Localized corrosion such as pitting may occur when two conditions are met simultaneously: i) An oxidizing species other than water is dissolved in the bulk environment and is depleted within the occluded cell, and ii) a strong acid forming anionic species is present in the bulk solution that can allow a low pH to develop in the occluded cell, e.g. chloride or sulphate ions. Stainless steels are susceptible to pitting in Cl-containing environments. As such, it is important that Cl concentrations be minimized so as to avoid the breakdown of the passive film and the development of a pit. Figure 35 illustrates pitting corrosion in stainless steel.

**Figure 35:** Pitting corrosion (left) [Laitinen T M J, 1999], and intergranular corrosion (right) in stainless steel (courtesy of G. Was).

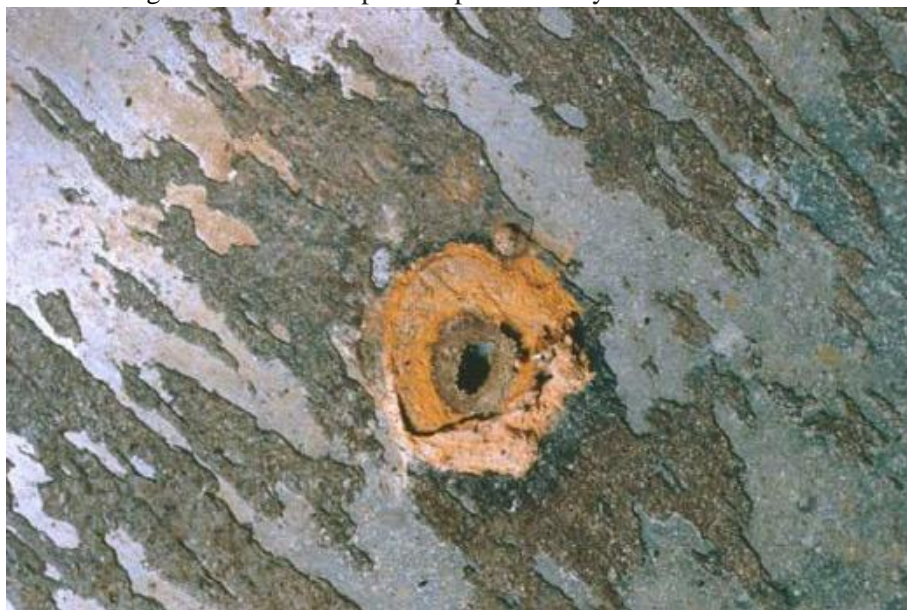
and MIC. Figure 36 is an example of a pit caused by MIC.

**Figure 36:** Microbial corrosion pit [Linhart P, 2006].

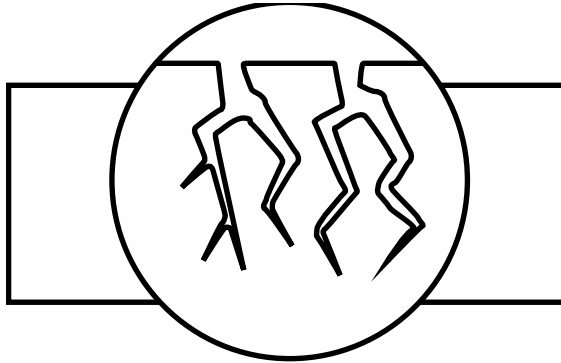
Stress corrosion cracking, SCC, is the formation and growth of cracks in a material under tensile stress in a corrosive environment. Figure 37 illustrates this type of corrosion-related damage.

**Figure 37:** Stress corrosion cracking (courtesy of G. Was) [Jones, 1996].

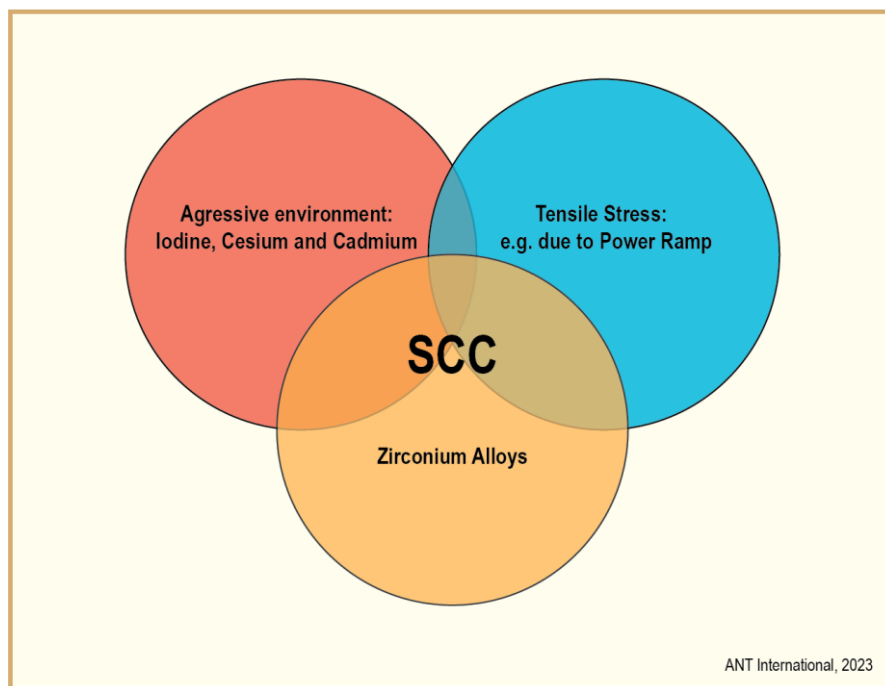
**Figure 38:** Schematic showing the three components involved in PCI

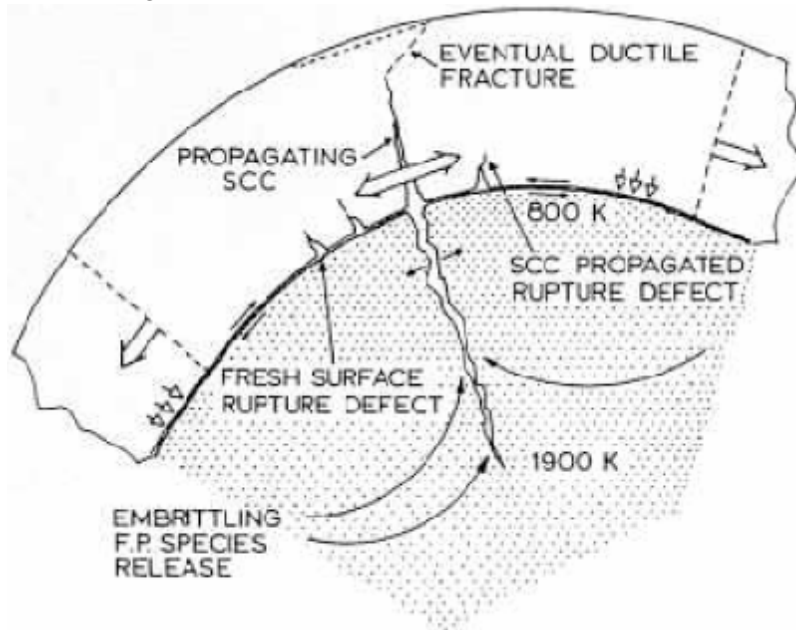
Figure 39: PCI [OECD, 2004].

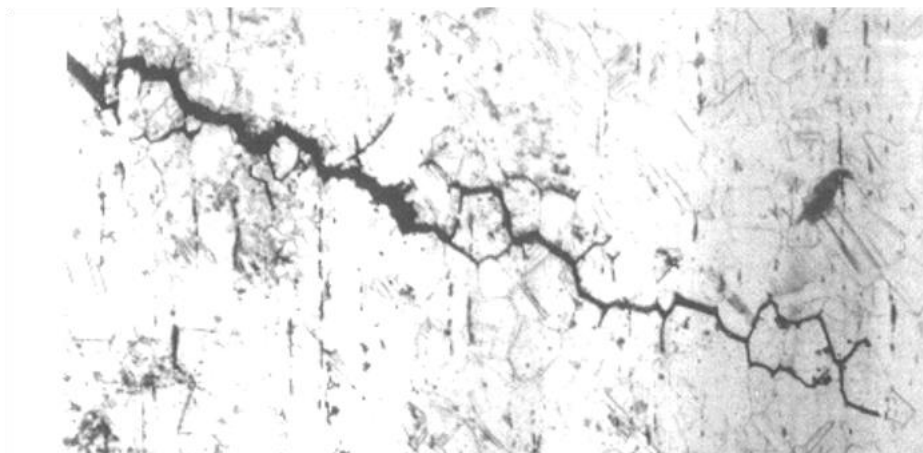
**Figure 40:** IASCC in 316 stainless steel (courtesy of G. Was).

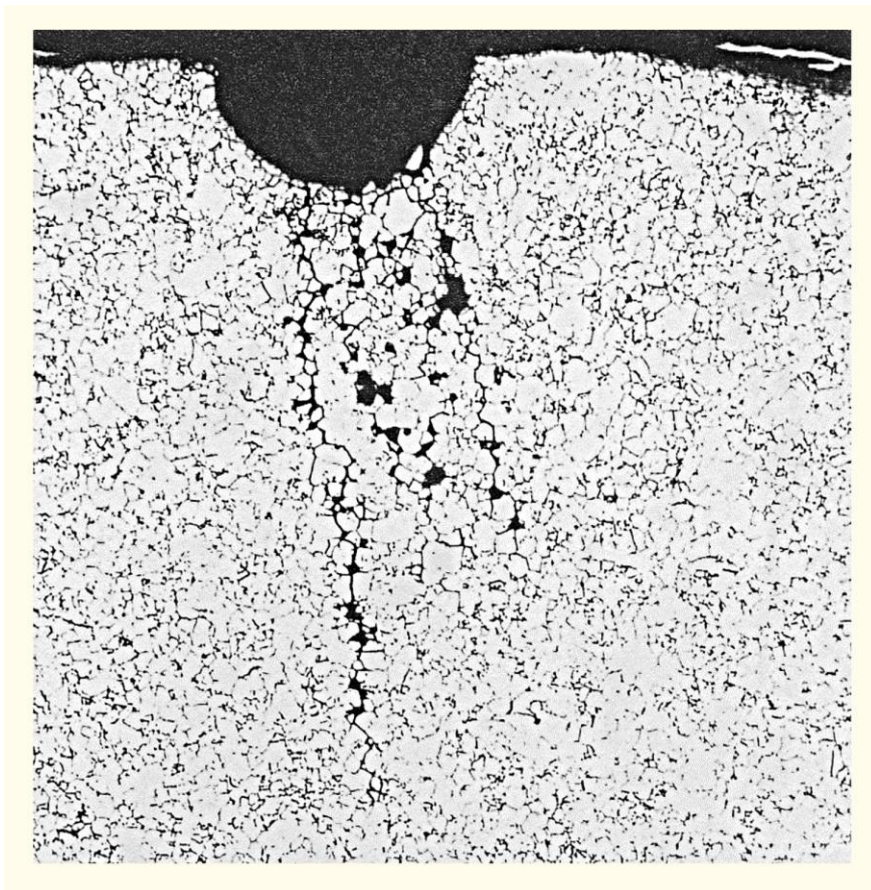
**Figure 41:** IGSCC developing below a corrosion pit (courtesy of G. Was).

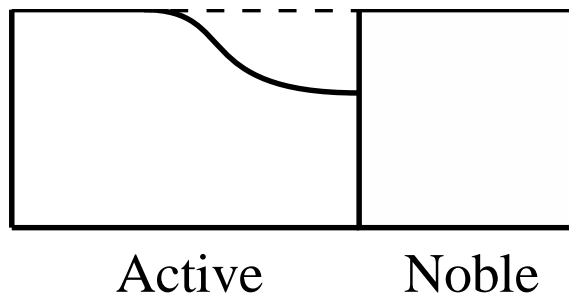
**Figure 42:** Galvanic corrosion (courtesy of G. Was) [Jones, 1996]

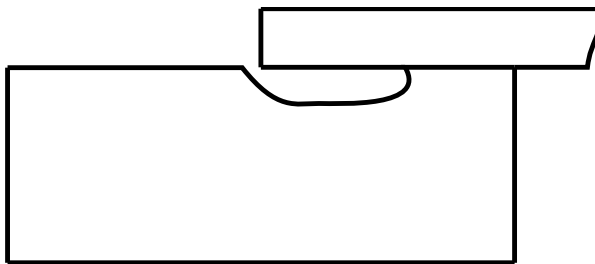
**Figure 43:** Crevice corrosion (courtesy of G. Was) [Jones, 1996]

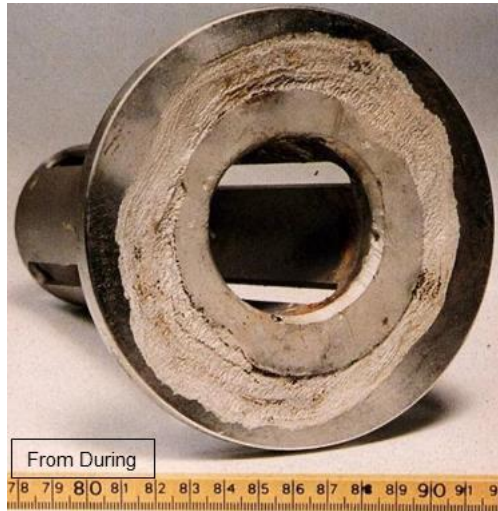
**Figure 44:** Stainless steel crevice corrosion [During, 1991]

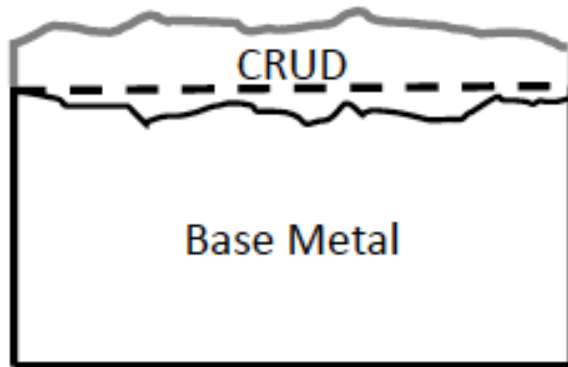
**Figure 45:** Assisted Corrosion (courtesy of M. Eyre) [Jones, 1996]

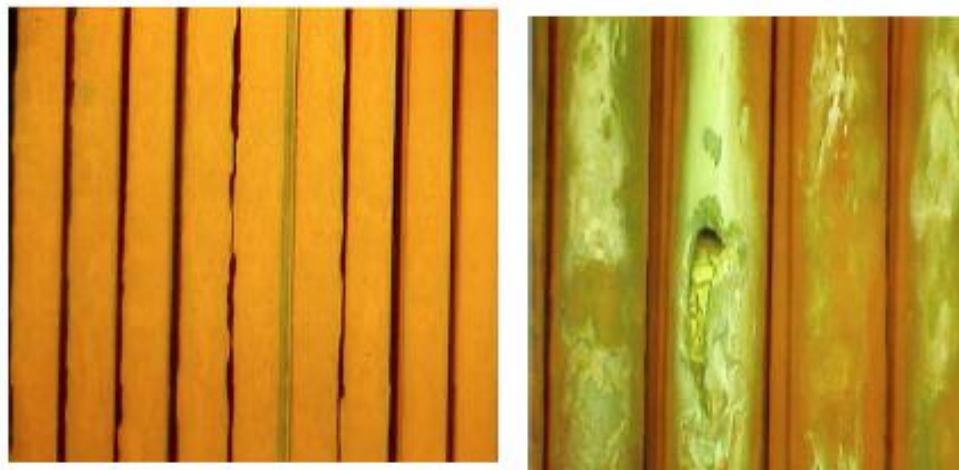
**Figure 46:** CRUD on BWR fuel (left) and localized corrosion failure of cladding (right) [Cheng and Yang, 2003]

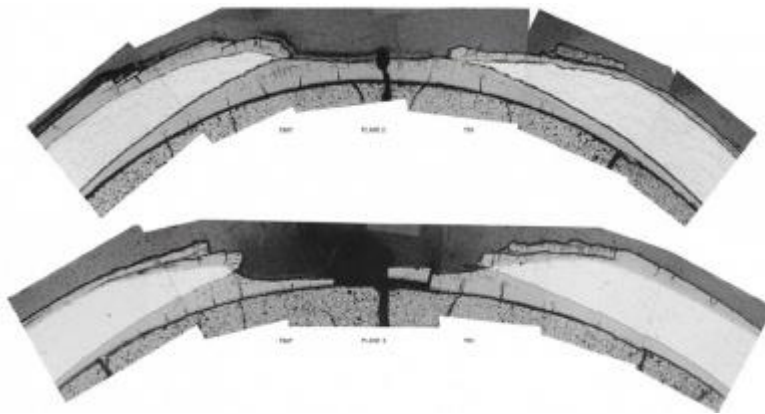
**Figure 47:** Cladding corrosion of TMI-1 Rod O11 at 3000 mm elevation [Garzarolli et al., 2001].
