Swedish Radiation Safety Authority

Authors: Richard Becker
Johan Öjjerholm

2017:02

Slow strain rate testing of copper
in sulfide rich chloride containing
deoxygenated water at 90 °C

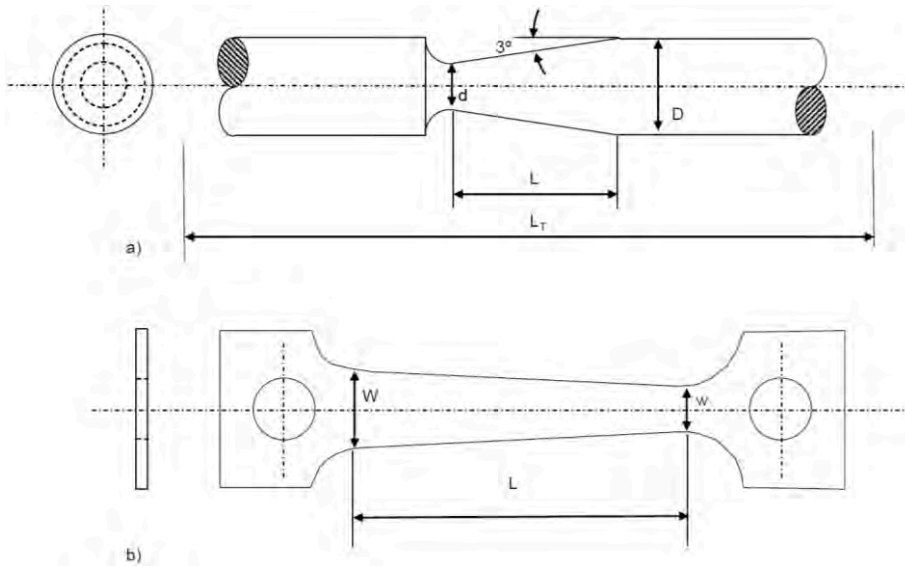
Figure 1: Schematic illustration of cylindrical and flat testing specimen with tapered gage section [5].

A way to estimate under which stress SCC does not occur for a certain material in a given environment is to use specimens with tapered gage section (Tapered Tensile Test, TTT) [4], see Figure 1.

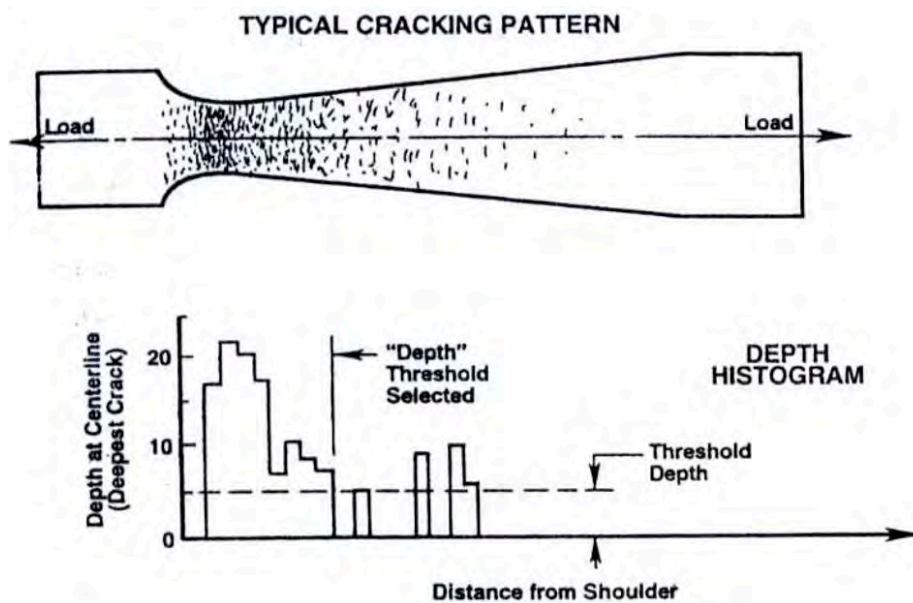
Figure 2: Crack patterns (top) and histogram (bottom) that shows the measured crack depth for cracks along a baseline drawn parallel to the specimen [6]. Post exposure examination can be done either in a Scanning Electron Microscope (SEM) on the surface of the specimen, or in a Light Optical Microscope (LOM) on the cross section of an axial polished specimen.

By performing the tensile testing very slowly in the appropriate conditions (through SSRT) to a pre-determined elongation, the stress under which no SCC occurs (if it occurs at all) can be estimated, see Figure 2.

Figure 3 shows an example of how a load threshold for the initiation of SCC can be estimated from a testing of the type that was exemplified in Figure 2.

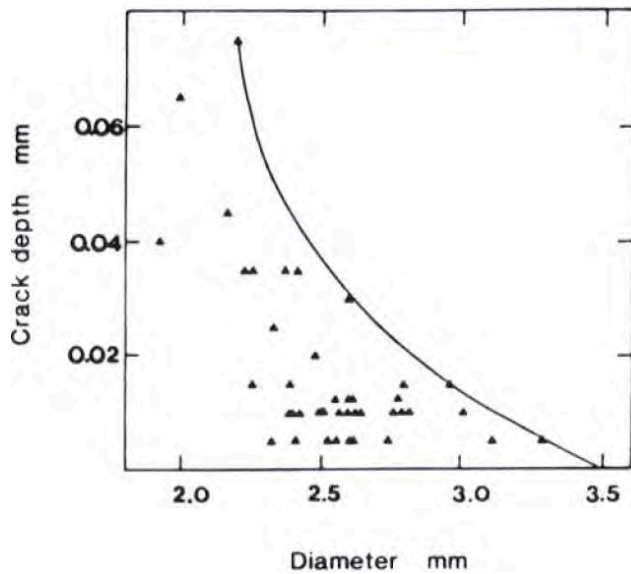
Figure 3: Distribution of crack along a tensile test specimen with tapered waist. The material was sensitized AISL 316 that had been tested under SSRT at 200°C and -300 mV SHE in water with 5 ppm chlorides [7]. Note that the stress in the material increases with the decreased diameter of the X-axis.

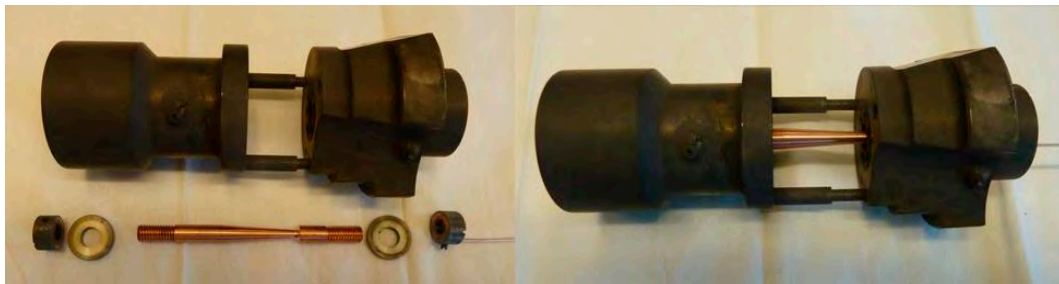
Figure 4: Photographs of a tapered specimen un-mounted (left) and mounted (right) before exposure.

The geometries of each specimen was measured before the test. After cleaning in an ultrasonic bath using organic solvents, the specimens were mounted electrically isolated in a holder to be placed in the autoclave, see Figure 4.

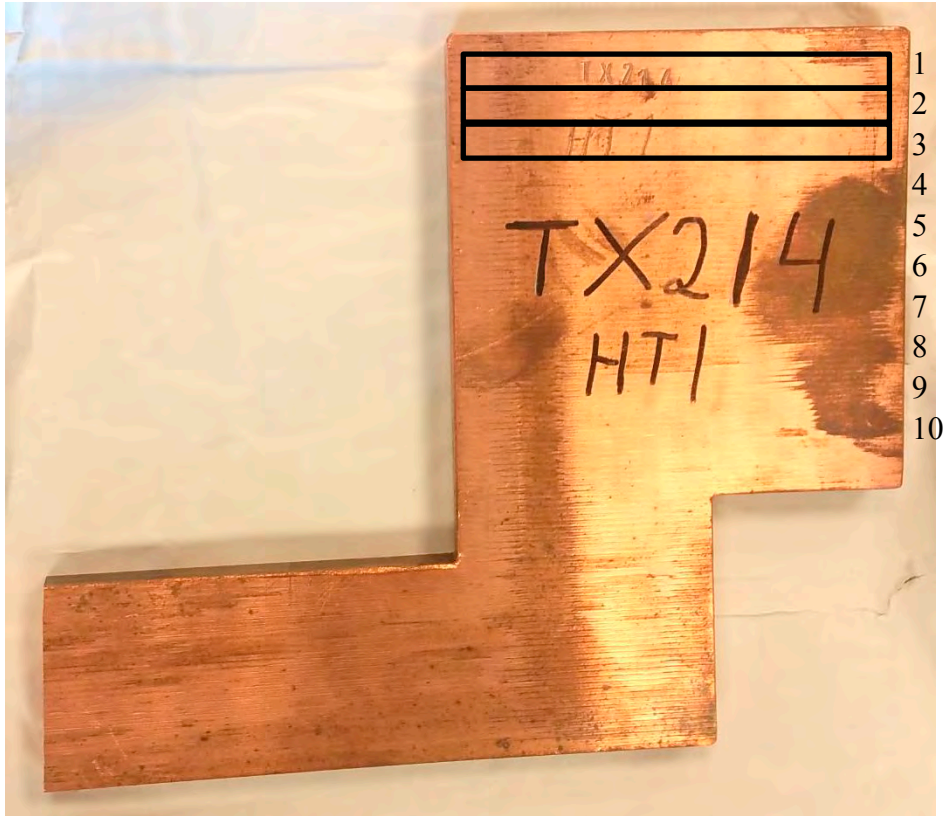
Figure 6: Photograph of the TX214 HT1 Cu-OFP material used in the experiments. The black boxes and numbers shows generally from where each specimen has been prepared.

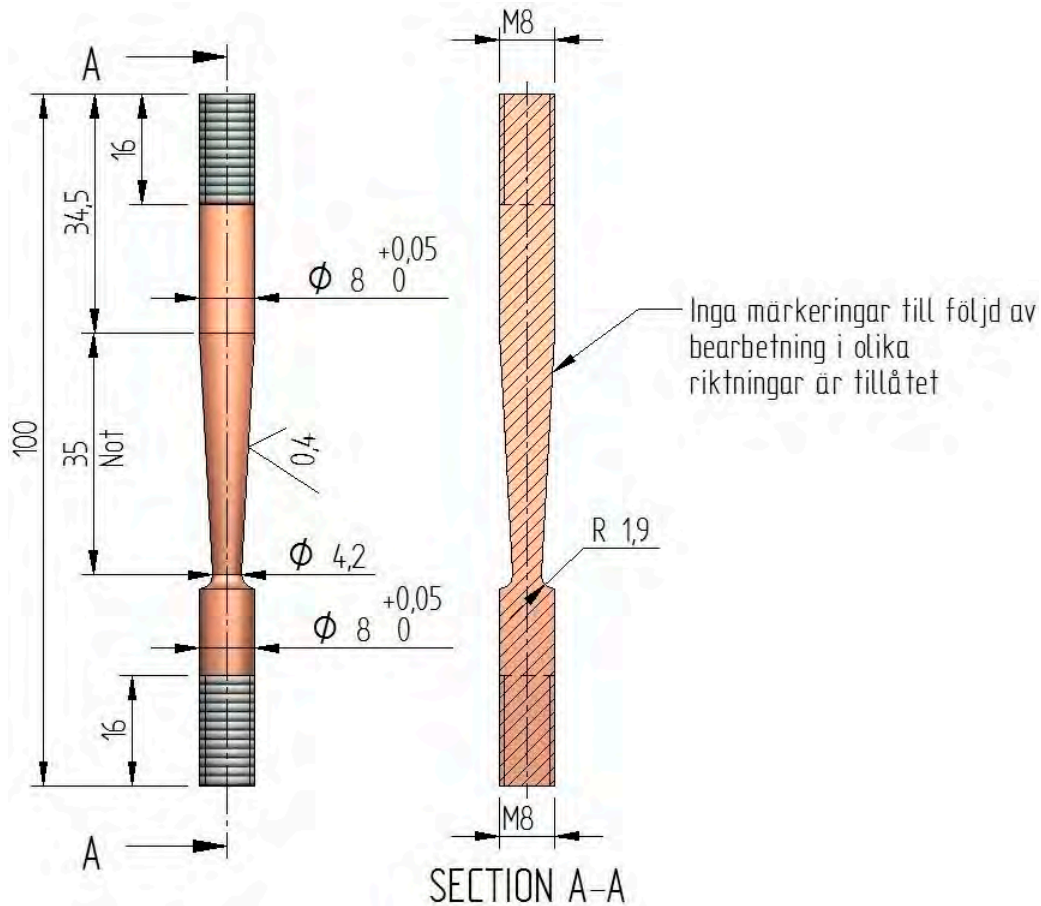
Figure 7: Final drawing of the specimen design.

Before the specimens could be produced, Finite Element Method (FEM) calculations were used to determine the specimen design and how to achieve the desired strain along the tapered gage section of the specimen, see Figure 7 and Figure 8.

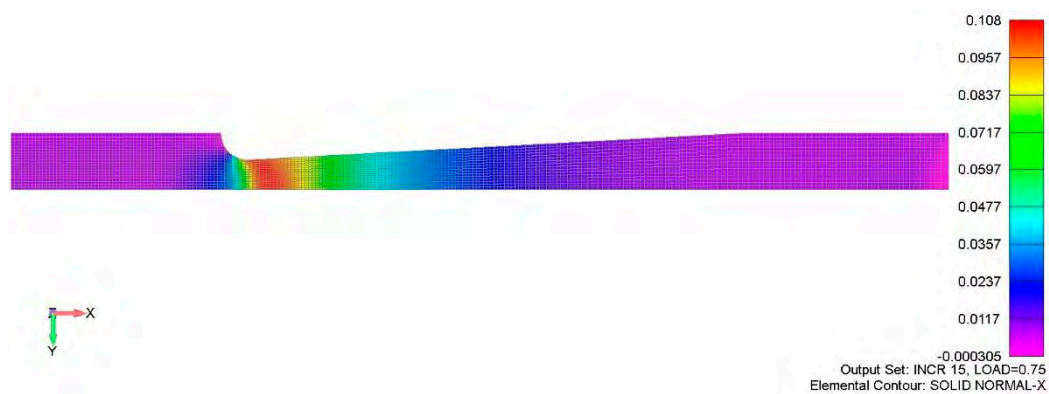
Figure 8: Illustration, based upon the FEM calculations, of the strain distribution axially along the tapered gage section of the specimen assuming a 1,500 μm elongation.

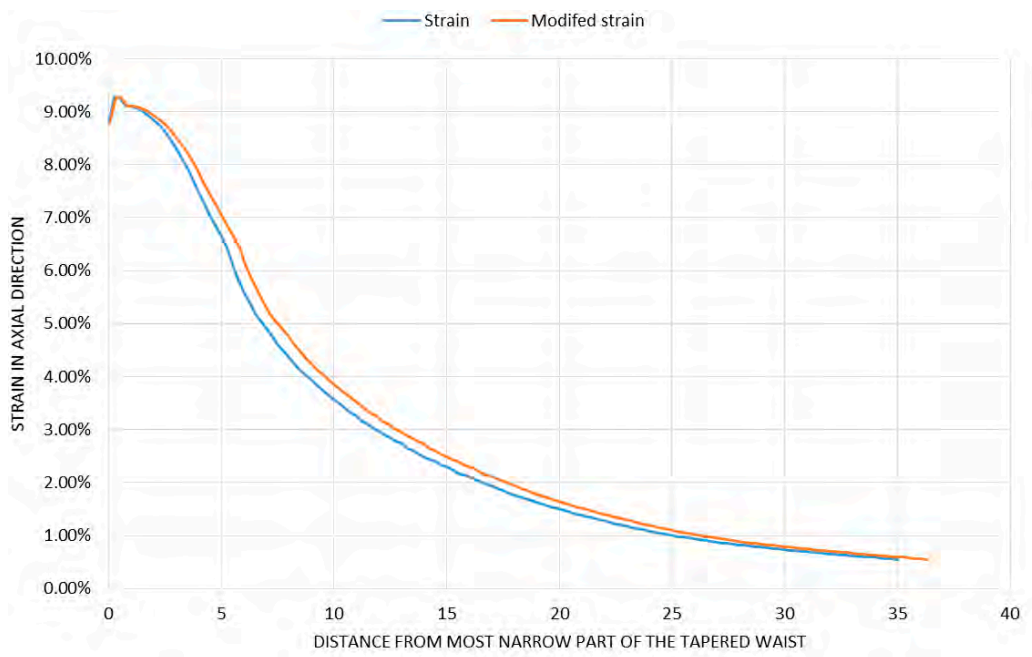
Figure 9: Unmodified (blue) and modified (orange) strain as a function of distance along the tapered gage section of the specimen, after application of 1,300 μm elongation.

Following the FEM calculations, the axial strain as a function of the distance to the narrowest part of the specimen gage section was calculated, see Figure 9. However, the FEM calculation used the un-deformed specimen as a frame of reference. For example, a point on the gage section that in the FEM simulation is shown to be 1 mm away from the narrowest part of the specimen, is on the real specimen measured to be 1 mm away from the narrowest part of the gage section plus the added strain over the 1 mm increment, added during testing. In order to change the frame of reference to the deformed specimen's, the elongation was proportionally distributed across the specimen gage section according to calculated strain. The unmodified curve in Figure 9 thus shows the strain as a function of distance on the un-deformed specimen gage section while the modified curve show the strain as a function of distance on the deformed specimen. During evaluation the latter curve was used.

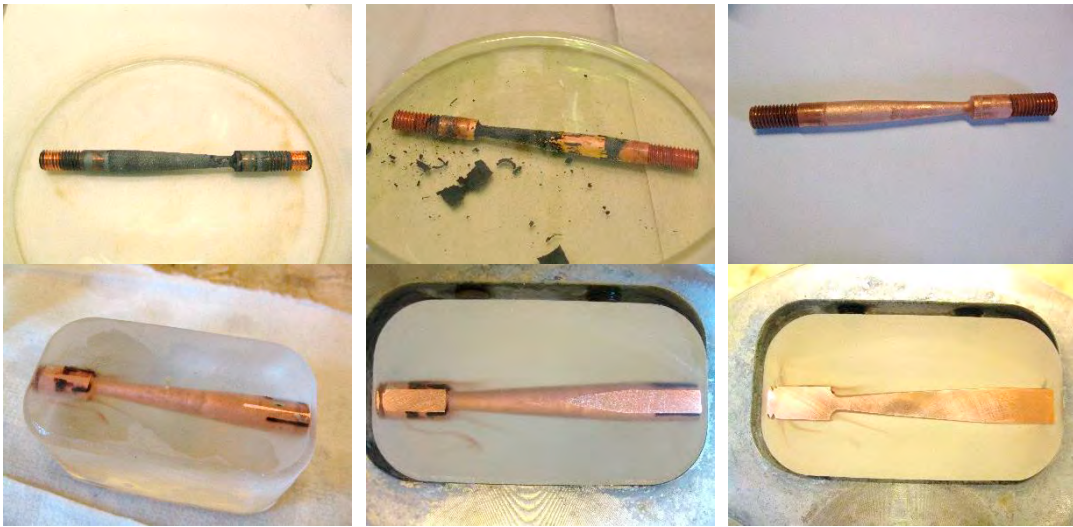
Figure 10: Cleaning in HCl (top row) and polishing (bottom row) of an exposed copper specimen.

Upon completion of each experiment except specimen 7 originating from experiment 5, each specimen was cleaned in room-temperature concentrated HCl (Sigma-aldrich, puriss, $\geq 37\%$) using a nylon brush to remove any copper sulfide on the surface. Following the cleaning, the surface of each specimen was inspected in either a LOM (Reichert Polyvar) and/or a Scanning Electrical Microscope (SEM, JEOL JSM6300) for the presence of cracks. The specimens were then encapsulated in a resin epoxy and polished parallel along the specimen length to fabricate a cross section, see Figure 10.

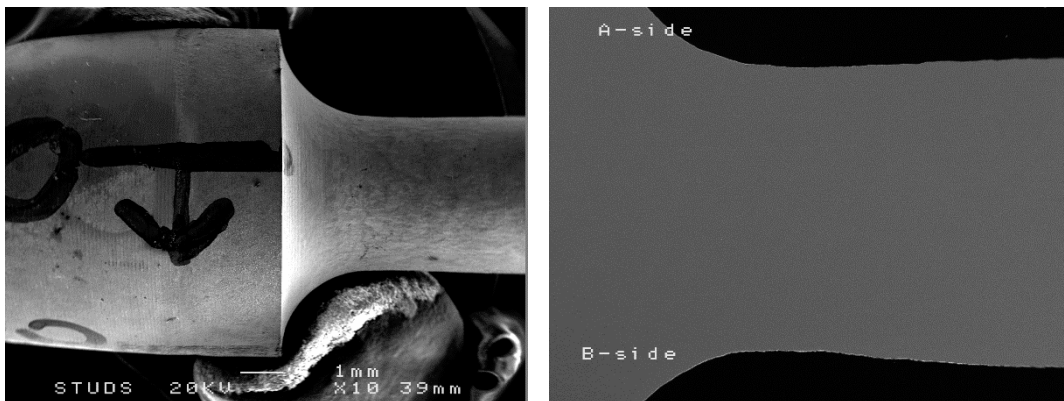
Figure 11: Images of unpolished (left) and polished (right) Cu specimen depicting how side A and B have been defined.

For each specimen, two sides having been examined corresponding to side A and B, see Figure 11, in a JEOL JSM6300 Scanning Electron Microscope (SEM).

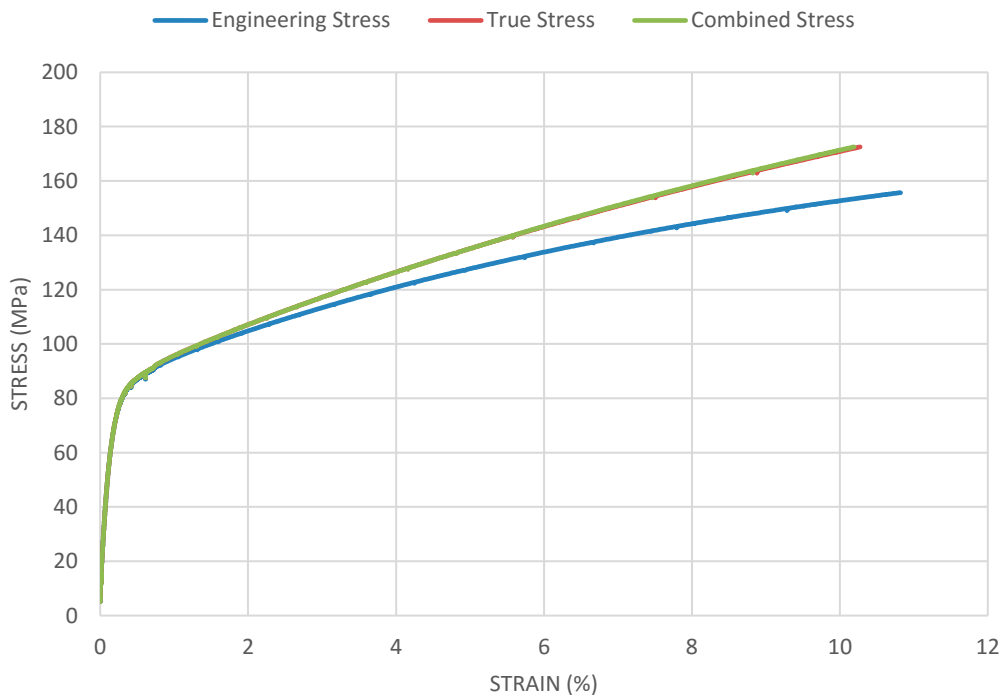
Figure 12: Engineering, true and combined stress vs strain from the tensile test performed at 90°C.

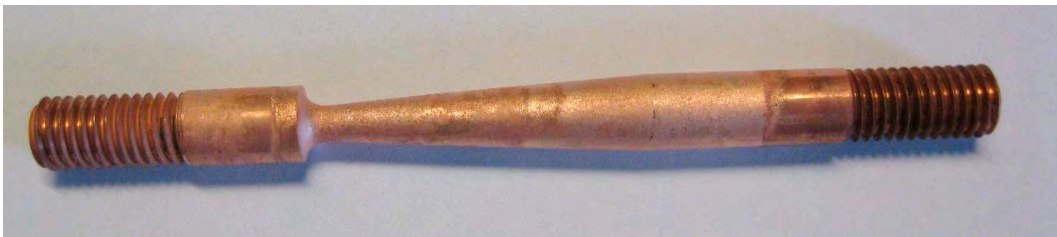
After experiment one, specimen #3 was removed from the autoclave, see Figure 13. Prior to the post-exposure examination, the length and the width of the thinnest part of the tapered gage section were measured and compared with the pre-exposure data, see Table 7.

Figure 13: Photograph of specimen #3 after exposure one.

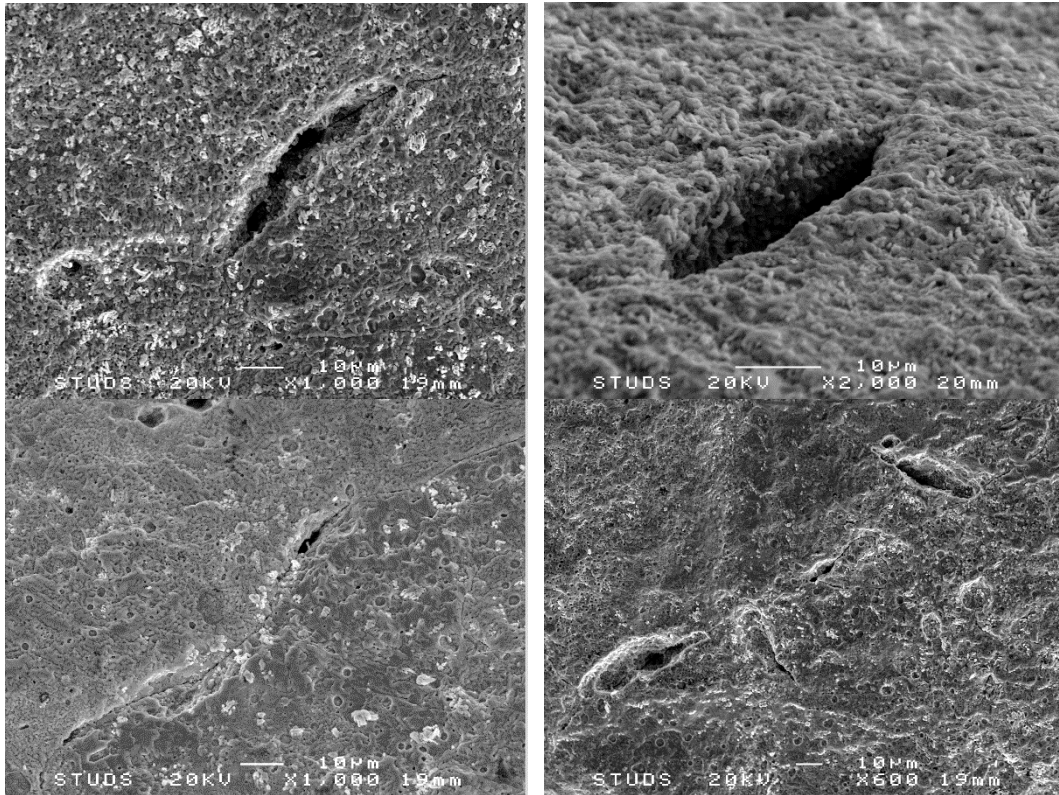
Figure 14: Selected SEM images of the specimen surface close to the narrowest part of the tapered gage section of the SSRT specimen exposed in experiment one.

The post-exposure examination with stereo microscopy of the surface of the specimen from experiment one revealed several surface defects attributed to cracks, see Figure 14.

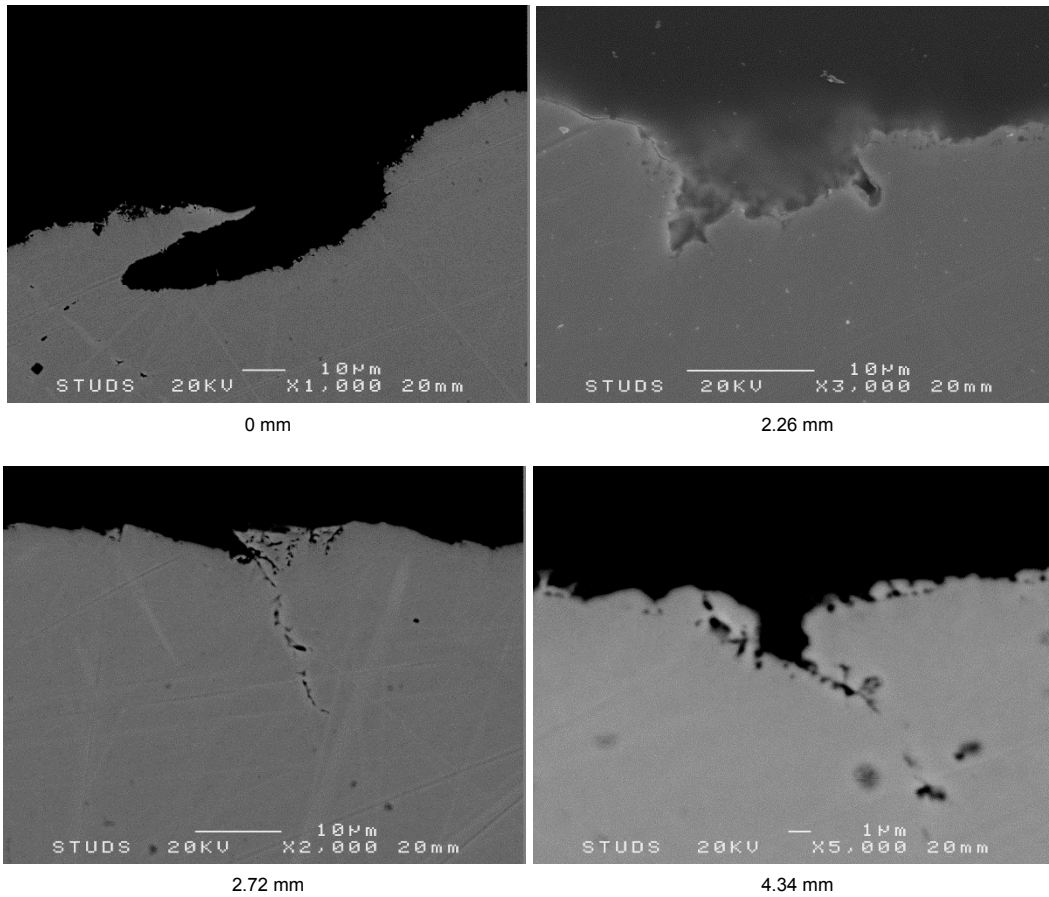
Figure 15: SEM images of the cracks observed and their distance to the narrowest part of tapered gage section on side A of the specimen cross section of the SSRT specimen exposed in experiment one.

The cross section analysis was performed in a SEM along both side A and side B. The distance from the narrowest part of the tapered gage section to any defects were measured, and the defects were visually analyzed to determine if they could be deemed to be a crack. Figure 15 and Figure 16 shows all defects observed for the specimen exposed in the first experiment that have been attributed to cracks. Additional defects, not positively attributed to cracks, are shown in Appendix F. A crack was in the evaluation defined as an observed surface defect, which had tended to grow preferentially to the surrounding material during the testing. The defects not attributed to cracks did not show such appearance, and analyzing these further was outside the scope of this work.

Equation 1 was used to estimate the true strain for which the crack had occurred, and Equation 2 was subsequently used to calculate the true stress that the strain corresponds to, see Table 8.

Crack	Distance from tapered gage section (mm)	True Strain (%)	True Stress (MPa)
A-1	0	8.78	162
A-2	2.26	8.92	162
A-3	2.72	8.67	161
A-4	4.34	7.51	154
B-1	0	8.78	161
B-2	2.6	8.74	161

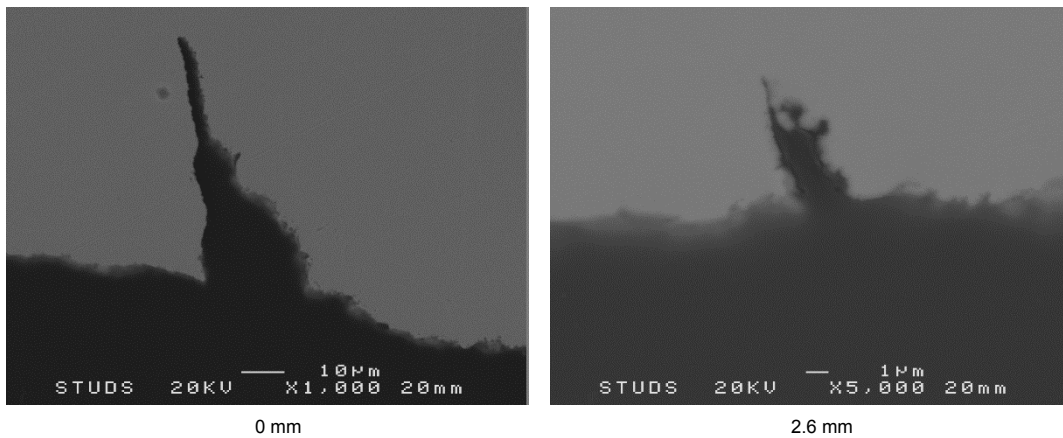
Figure 16: SEM images of the cracks observed and their distance to the narrowest part of tapered gage section on side B of the specimen cross section of the SSRT specimen exposed in experiment one.

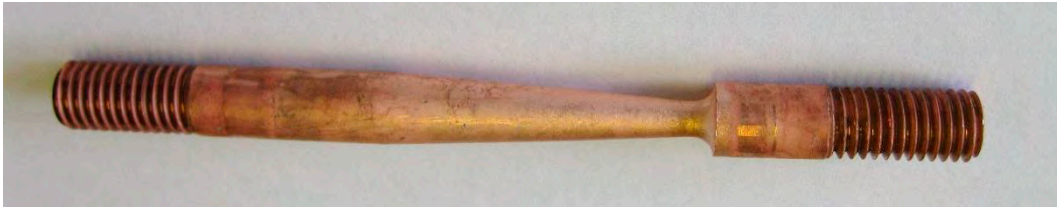
After experiment two, specimen #4 was removed from the autoclave, see Figure 17. Prior to the post-exposure examination, the length and the width of the thinnest part of the tapered gage section were measured and compared with the pre-exposure data, see Table 9.

Figure 17: Photograph of specimen #4 after exposure two.

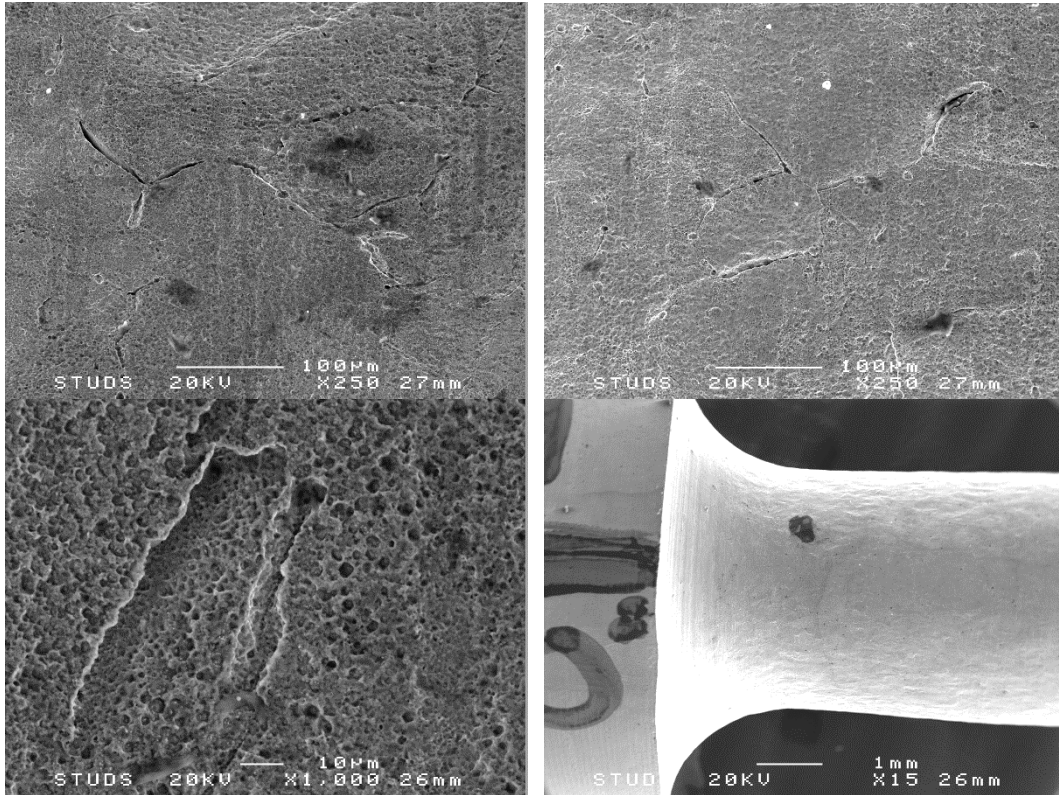
Figure 18: Selected SEM images of the specimen surface close to the narrowest part of the tapered gage section of the SSRT specimen exposed in experiment two.

The post-exposure examination using microscopy of the surface of the specimen from experiment two revealed several surface defects attributed to cracks, see Figure 18.

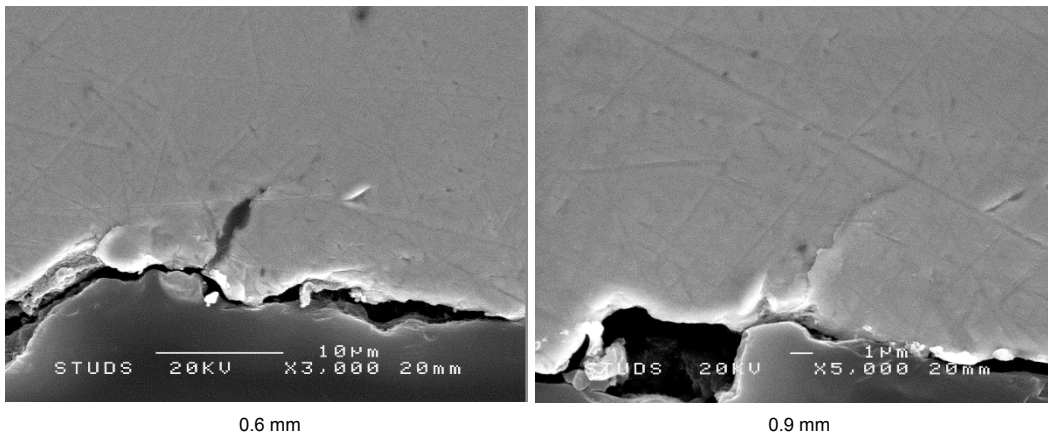
Figure 19: SEM images of the cracks observed and their distance to the narrowest part of tapered gage section on side B of the specimen cross section of the SSRT specimen exposed in experiment two.

The cross section analysis was only performed in SEM along side B, which was thought to be representative for the specimen as a whole. The distance from the narrowest part of the tapered gage section to any defects were measured, and the defects were visually analyzed to determine if they could be deemed to be a crack. Figure 19 shows all defects observed for the specimen exposed in experiment two that have been attributed to cracks. Additional defects, not positively attributed to cracks, are shown in Appendix G.

Equations 1 and 2 were used to estimate the true strain for which the crack had occurred, and to calculate the true stress that the strain corresponds to, see Table 10.

Crack	Distance from tapered gage section (mm)	True Strain (%)	True Stress (MPa)
B-1	0.6	9.10	163
B-2	0.9	9.17	164

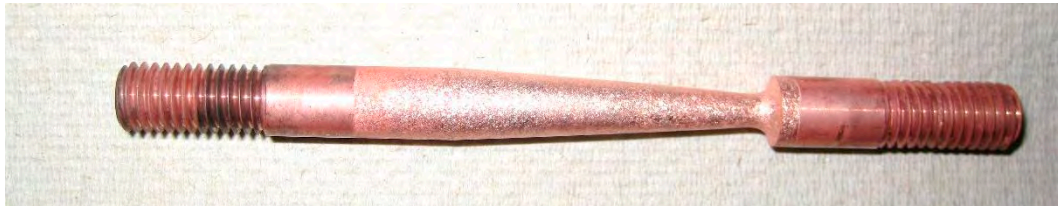
After exposure three, specimen #5 was removed from the autoclave, see Figure 20. Prior to the post-exposure examination, the length and the width of the thinnest part of the tapered gage section were measured and compared with the pre-exposure data, see Table 11.

Figure 20: Photograph of specimen #5 after exposure three.

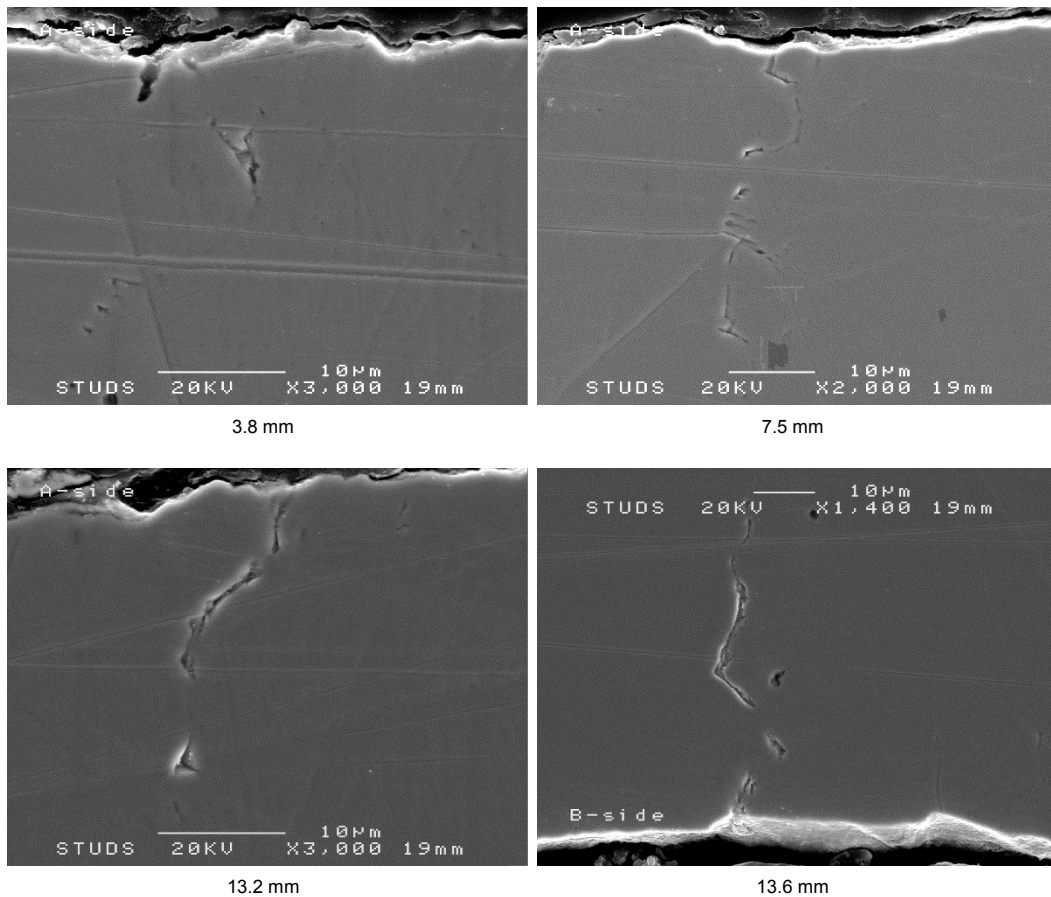
Figure 21: Example of SEM images of the defects observed and their distance to the narrowest part of tapered gage section on side A and B of the specimen cross section of the SSRT specimen #5 exposed in exposure three.

The post-exposure examination using microscopy of the surface of the specimen from exposure three revealed a very rough/coarse surface containing anomalies resembling craters, with very rough inner surfaces. Several defects could be seen when tilting the specimen inside the microscope, but none could positively be attributed to cracks. No microscopy images of the surface of the sample were collected from this post-exposure examination. During the polishing procedure, the specimen was tilted so that the polished surface would contain as many of these defects as possible.

The cross section analysis was performed in an SEM along both sides of the specimen. For this specimen, no defects could positively be attribute as a crack, although several crack-like defects were observed. Figure 21 shows some examples of these defects, while Appendix H shows all defects observed for the specimen exposed in exposure three.

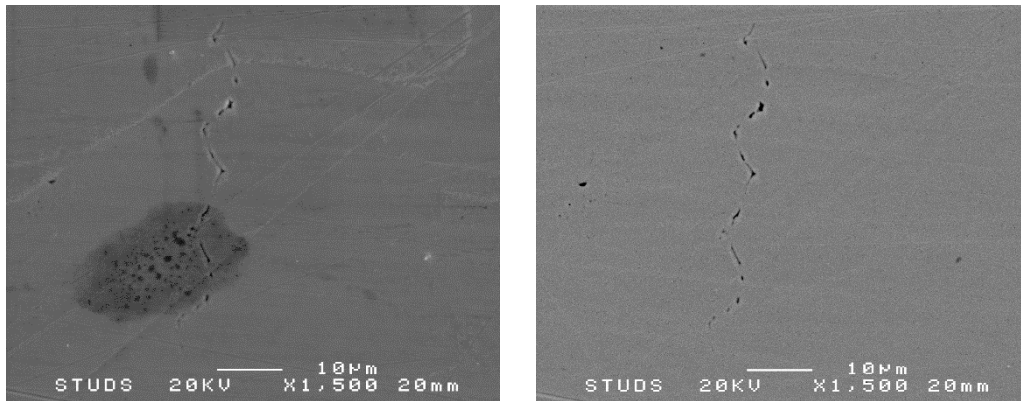
Figure 22: Crack like defects observed in the inner section of specimen #5.

For comparison, additional regions were examined for similar crack-like defects on this specific specimen. Both the inner part of the specimen not directly exposed to the sulfide containing water, and the specimen head and full width gage section were examined for the presence of the surface defects (that were observed on the edges of the narrow gage section of the specimen). The purpose of this comparison was to look for similar defects in these regions. If any similar defects could be observed there as well, the defects most likely does not originate from the exposure to the sulfide containing water. The results are shown in Figure 22 for the inner section of the specimen, and in Figure 23 for the head and full width gage section, and they show that similar defects indeed could be located both inside the material, in the specimen head and in the full width gage section. It should however be noted that the amount of defects located inside the material, in the head and in the full width gage section was lower than what could be observed in the edges, but the defects could clearly be identified. The crack-like defects observed in the tapered gage section does thus most likely not originate from the exposure, and the origin of these defects have not been identified and it is considered to be outside the scope of the current work. All defects, on the edges of the tapered gage section, inside the material and in the specimen head and full width gage section run vertically in the images, which corresponds to perpendicular to the axial length of the Cu specimen.

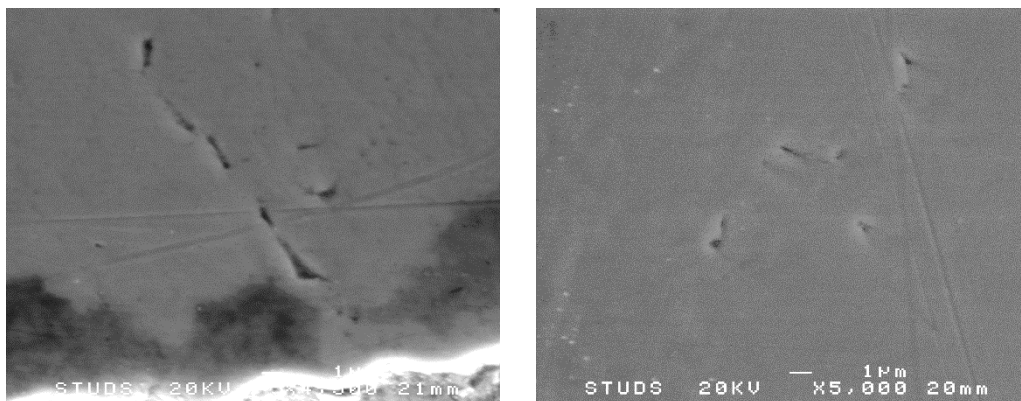
Figure 23: Crack like defects observed in the head (left) and full width gage (right) section of specimen #5.

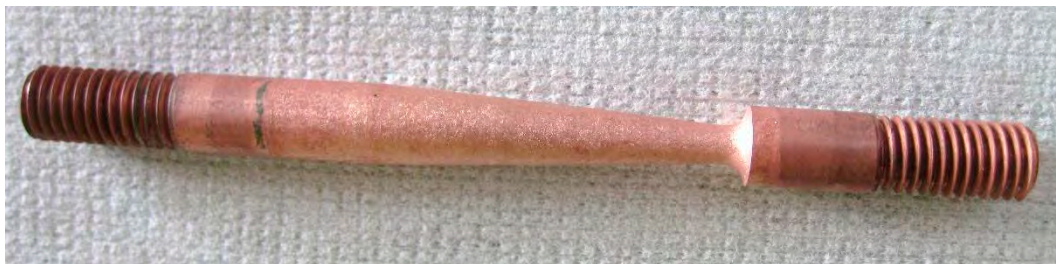
After experiment four, specimen #6 was removed from the autoclave, see Figure 24. Prior to the post-exposure examination, the length and the width of the thinnest part of the tapered gage section were measured and compared with the pre-exposure data, see Table 12.

Figure 24: Photograph of specimen #6 after exposure four.

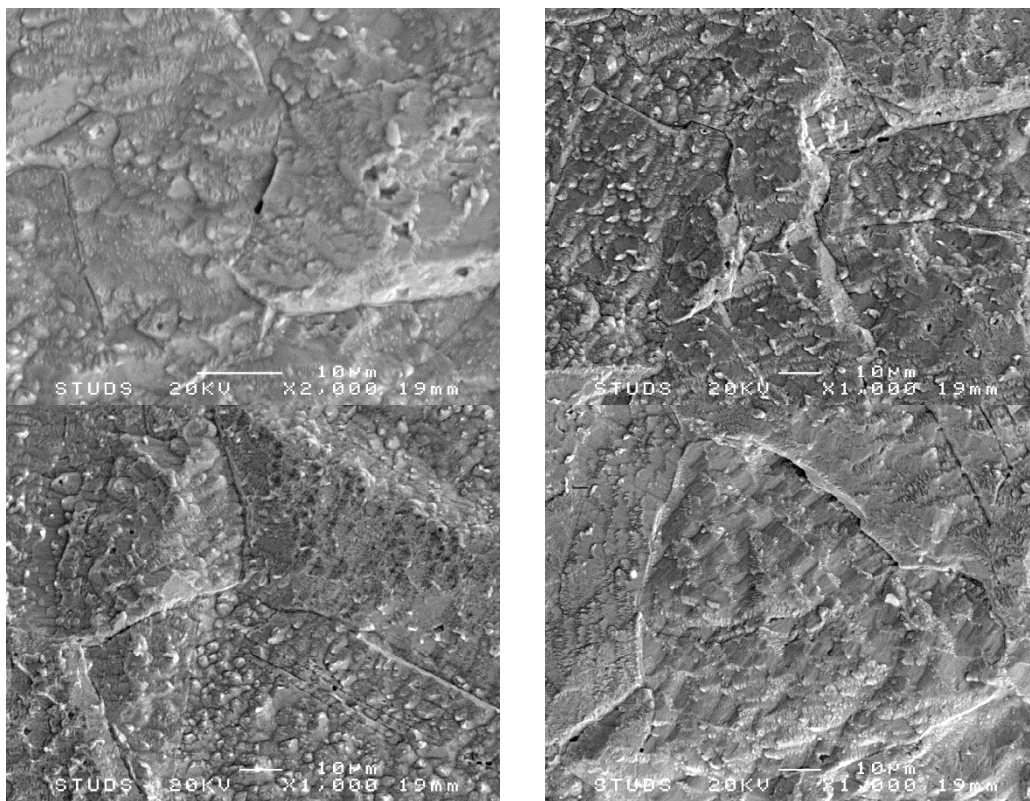
Figure 25: Selected SEM images of the specimen surface close to the narrowest part of the tapered gage section of the SSRT specimen #6 exposed in experiment four.

The post-exposure examination using microscopy of the surface of the specimen from experiment four revealed several surface defects, but none could positively be attributed to cracks, see Figure 25. The surface defects were deemed to be related to the general corrosion of the specimen and possibly the deformation during testing, compare e.g. Figure 14. The surface following the exposure was in general rough and uneven, and the general appearance was similar to that of specimen #5 exposed during experiment three.

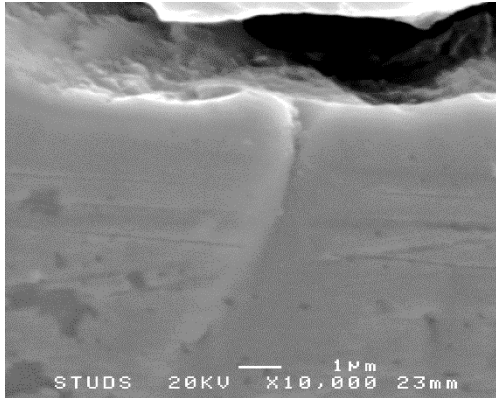
~0.0 mm

Figure 26: SEM image of a defect observed and its distance to the narrowest part of tapered gage section on side A of the specimen cross section of the SSRT specimen exposed in experiment four. Note that the defect is so small that it most likely should not be attributed to a crack.

The cross section analysis was performed in an SEM along both side A and side B. The distance from the narrowest part of the tapered gage section to any defects were measured, and the defects were visually analyzed to determine if they could be deemed to be a crack. Only one defect was observed that possibly could be attributed to a crack, but the defect is very small, around four micrometers, which suggests that it in fact shouldn't be attributed to a crack. Figure 26 shows this defect, while Appendix I shows all defects observed in specimen #6 exposed during experiment four.

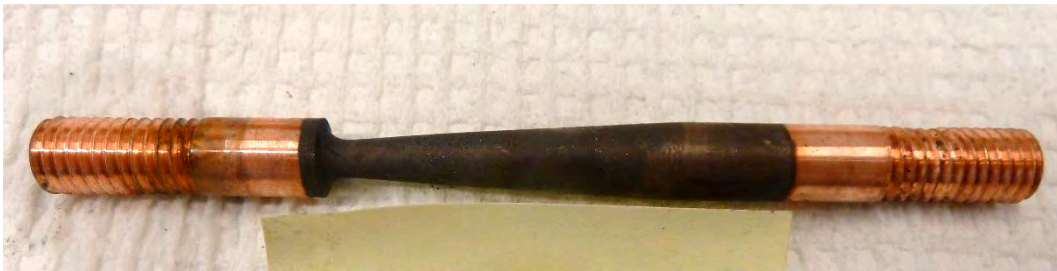
After experiment five, specimen #7 was removed from the autoclave, see Figure 27 the length was measured and compared with the pre-exposure data, see Table 13.

Figure 27: Photograph of specimen #7 after exposure five.

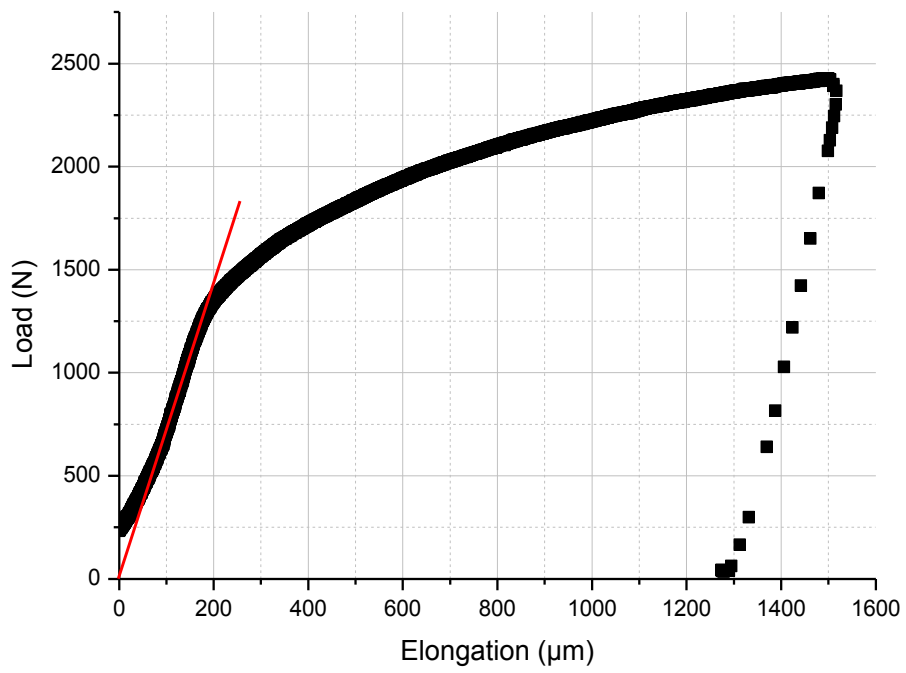
Figure A 5: Load vs elongation during the first exposure.

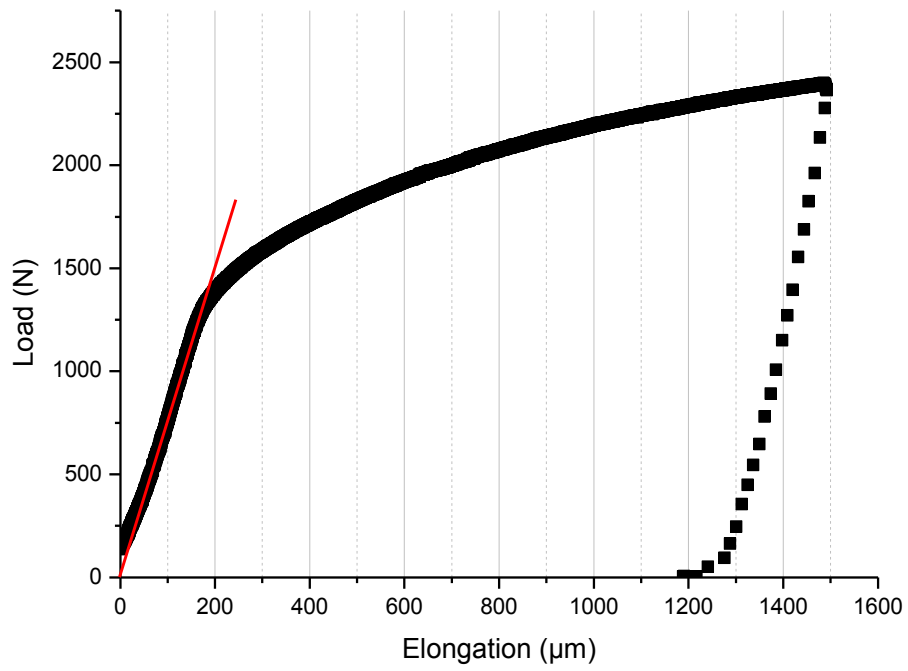
Figure B 5: Load vs elongation during the second exposure.
