Swedish Radiation Safety Authority

2009 assessment of radiation  
safety in the Swedish nuclear  
power plants

Title: 2009 assessment of radiation safety in the Swedish nuclear power plants  
Report Number: 2009:13e  
Author: Lennart Carlsson  
Date: April 2009

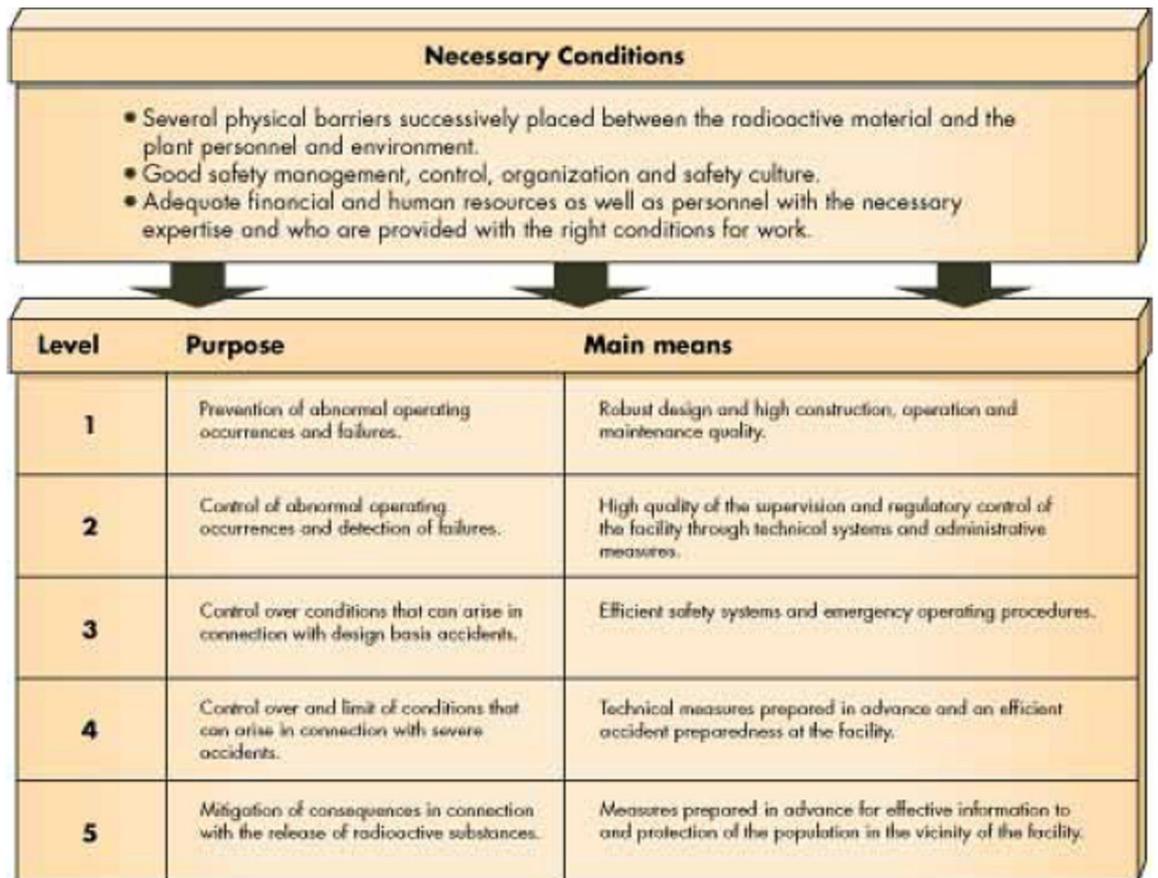
Figure 1. The necessary conditions for a defence in depth system and the different levels of the system

Safety at Swedish nuclear power plants must protect humans and the environment from the harmful effects of nuclear operations. Safety work shall be based on the so-called principle of defence in depth - see Figure 1 - which has been ratified in the International Convention on Nuclear Safety and in SSM's regulations, as well as in many other national nuclear safety regulations.

Defence in depth also assumes that a number of different types of engineered systems, operational measures and administrative procedures exist to protect the barriers and maintain their effectiveness. This is necessary both during normal operations and under anticipated operational deviations and accidents. If this fails, measures should be in place to limit and mitigate the consequences of a severe accident.

Analyses are performed to identify which barriers must function and which parts of the different levels of the defence in depth system must function during different operational conditions. When a plant is in full operation, all barriers and parts of the defence in depth system must be functional. When the plant is shut down for maintenance, or when a barrier or part of the defence in depth system has to be taken out of operation for other reasons, this must be compensated by other measures of a technical, operational or administrative nature.

If one level fails, the next level will take over. Failure of equipment or a manoeuvre at one level, or combinations of failures occurring at different levels at the same time, must not be able to jeopardise the performance of subsequent levels. Independence between the different barriers of the defence in depth system is essential in order to achieve this.

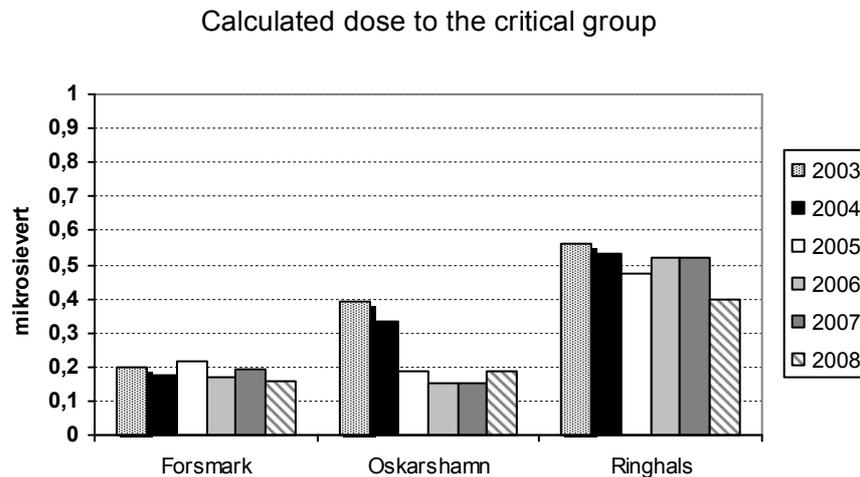
*Diagram 1:* Release of radioactive substances to the atmosphere and water from nuclear power plants.

*Diagram 1* shows the radiation doses calculated from the release of radioactive substances from nuclear power plants for the period 2003 – 2008. The radiation doses (quoted in  $\mu\text{Sv}$ ) are for people living close to a nuclear power plant and who are expected to receive the highest doses: the critical group. SSM notes the release of radioactive substances from the nuclear power plants in 2008 has resulted in a calculated dose to the most exposed person in the critical group which by large margins is lower than the environmental quality goal of 10 microsievert.

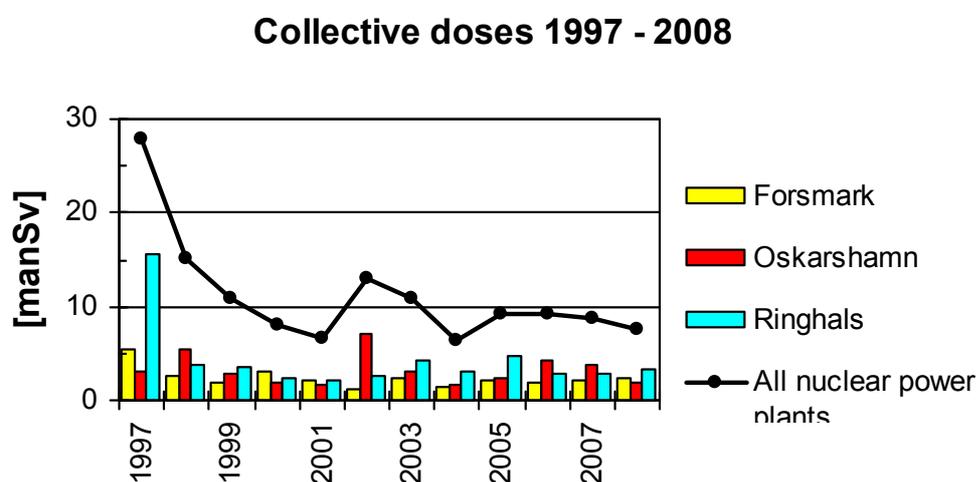
Diagram 2. Annual collective dose (manSv) to personnel at the Swedish nuclear power plants

SSM considers that the radiation doses to personnel at the nuclear power plants in 2008 are reasonable, taking into account the existing radiation environment and the work performed. The total collective dose for all the plants during the year was 7.7 manSv. SSM notes that no individual has received a dose in excess of the established dose limits and that no-one has
